Impact of Landslide on Blasting in the Quarry Dobkovičky

Bohumil Svoboda^{a*}, Jan Svoboda, Radim Kašpar

Geodyn spol. s r.o. Bajkonurská 736, Prague 11, Czech Republic

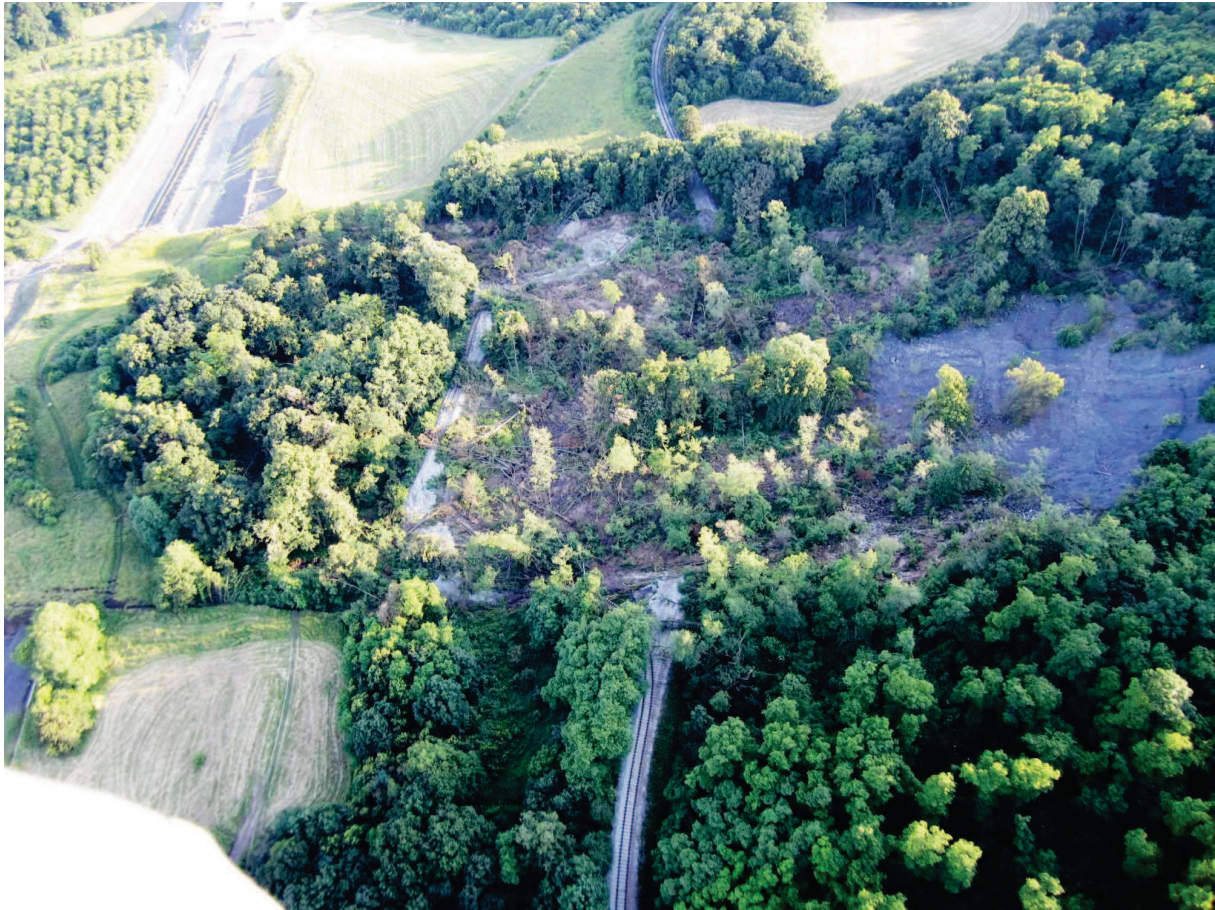
Fig. 2: The landslide area, smashed railway and buried motorway

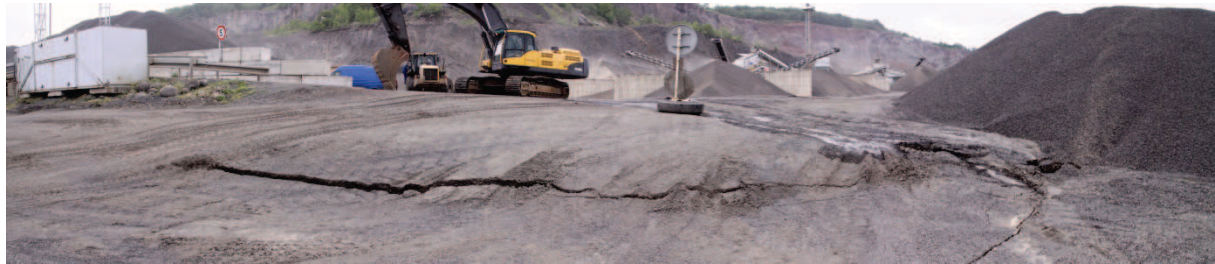
Fig. 3: Open cracks at the offices of the quarry Dobkovičky on the day before landslide
