CHARACTERISTIC OF DAMAGE TO THE STRUCTURAL ELEMENT BY CREATING ITS “DEGRADATION PROFILE”

J. Frankl^{*}

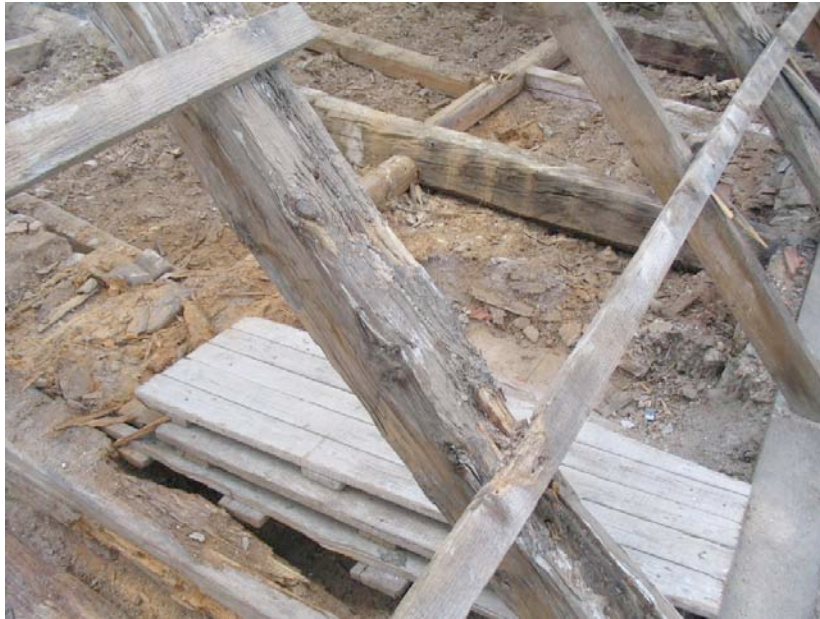
What was chosen for the experiment was the bottom part (the base) of a rafter from a roof beam structure of a historic building in the centre of Prague. According to the data collected from the construction documentation, the roof beam structure dates back from 1866 - 1868 when the last known reconstruction of the building was taking place. The roof beam structure of the building's gable roof consisted of 13 trusses. The tested part comes from a rafter on the western side of truss No. 8 (Fig. 1). The rafter base was damaged by wood-damaging fungi (brown rot). The damage took place long time ago. At the time of the survey of the quality condition of wood elements and the realization of repairs, wood-damaging fungi were in a non-active stage. By performing laboratory analysis using the cultivation method, the presence of viable germs of wood-damaging fungi of the *Trametes* and *Gloeophyllum* genera was identified in fragments of wood from the damaged part.

Fig. 1: View of the roof beam structure.

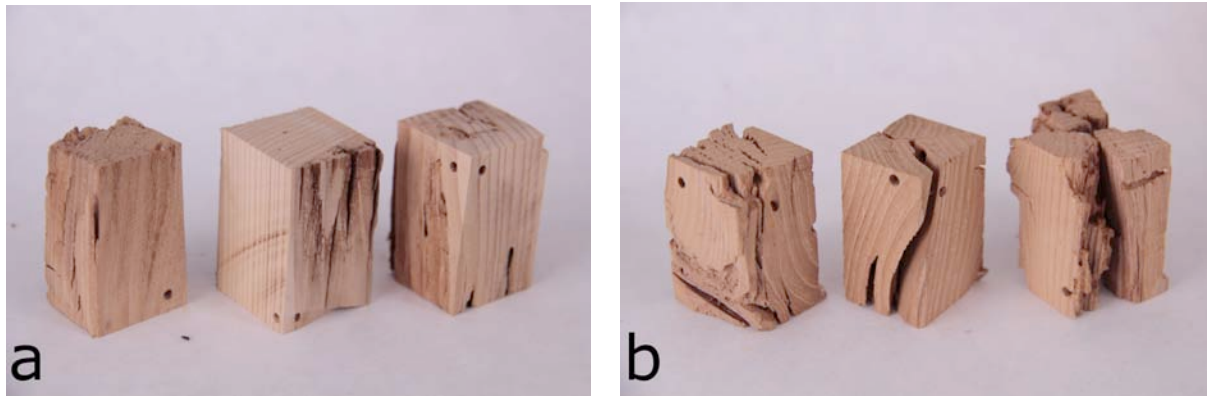
Fig. 3: Examples of segments originated by cutting beams before the production of exact test samples, a) segments with the potential to produce a test sample, b) segments with no opportunity to produce a test sample.

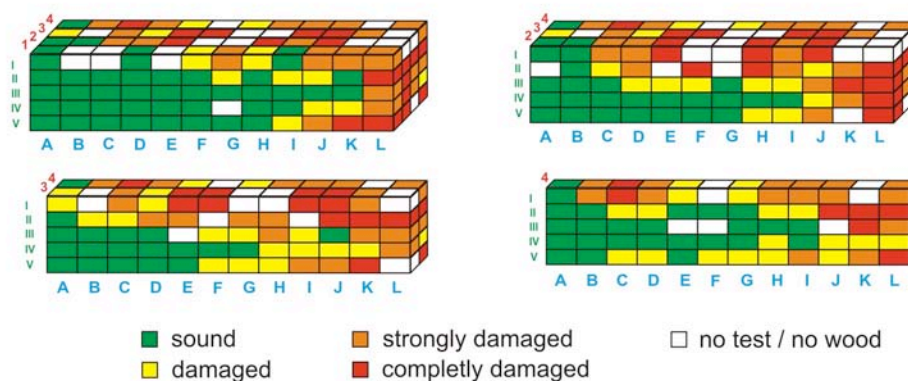
Longitudinal Cuts of the Rafter

Based on this division, a degradation profile was prepared, i.e. the graphic depiction of the changes in the wood strength due to degradation by wood-damaging fungi in individual parts of the base part of the rafter. The drawing of the degradation profile in longitudinal sections of rafters (in the pre-selected network of 12 x 5 x 4 segments) is shown in Fig. 5.

Fig. 5: Examples of segments originated by cutting beams before the production of exact test samples, a) segments with the potential to produce a test sample, b) segments with no opportunity to produce a test sample

wood-damaging fungi (darkening of wood, fissures, disintegration into minuscule particles). The results show that the transition zone between the heavily damaged timber (with a decrease in strength by more than 50%) and healthy wood is relatively narrow and varies in the order of millimetres. The degradation profile of the damaged element reveals changes in shape and considerable reduction of the effective cross section (of sound wood) in the element at the place it was deposited on the top plate.
