## STRUCTURAL TECHNICAL INSPECTION AND PROJECT PREPARATION FOR RECONSTRUCTION OF REINFORCED CONCRETE RAILWAY VIADUCT IN KRNSKO

**Abstract:** *This paper describes undertaking and results of structural technical inspection of reinforced concrete railway viaduct in the Krnsko municipality and subsequent project for preparation for its reconstruction as based on the findings of this inspection.*

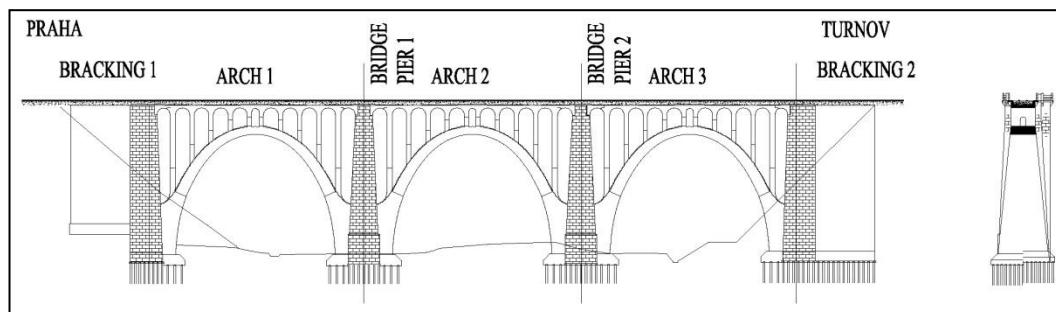
*Fig. 2: Longitudinal chart and cross section of the Krnsko viaduct.  
The examination was carried out in indicated places.*

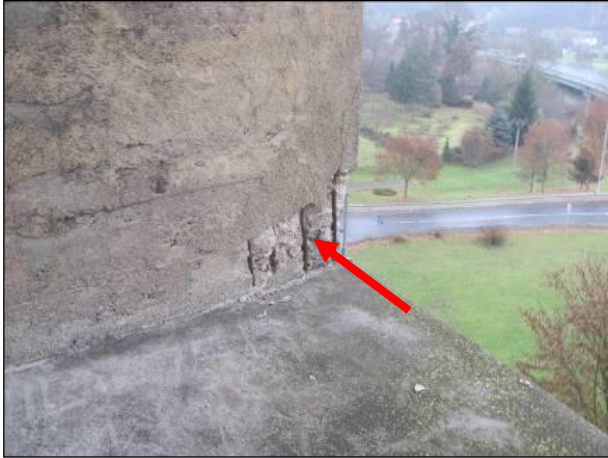
The inspection found out that visible parts of the bearing structure of the bridge do not show marks of significant defects as may be excessive deformations, remarkable cracks, crashed concrete parts etc., which would signal reduced loading capacity or even loss of the whole structure stability. Basic defect of inspected concrete, caused already during initial construction is its high patchiness (Fig. 4) found by almost half of core drills and visible in the form of gravel pockets even in large area of the visible surface. The structural concrete had been further damaged mainly due to intense leakage caused by non-functional hydro-insulation of the deck and impact of weather conditions. Its classification according to currently valid standard ČSN EN 206-1 was done individually for individual structural parts and varies in the marking range C16/20 to C 25/30. Found average tensile strength of surface layers reached about 2 MPa. Content of chloride ions in the surface layer up to 30 mm was assessed as low in accordance with ČSN EN 206-1. From the aspect of conditions for reinforcement corrosion the decisive parameter is depth of carbonation which is rather variable in the inspected structure. Good situation was found in main arches, the bearing reinforcement of which is located almost all in non-carbonated part of the concrete. Markedly worse situation is on the contrary in lateral walls of arcade system. Concrete columns and abutments have such a poor steel reinforcement that it has not been reached at all in the depth of 70 mm (measured from the surface). Corrosion of reinforcement found by probes was mostly surficial but locally also extreme, with the section thinner by more than 50 % (Fig. 3). On the surface of main wall arches is degraded the original water-insulation screed failing to fulfil its function long ago. The result are massive efflorescence with leaky cracks on the bottom face and sides of vaults, areal surficial degradation of upper face with local deterioration in bigger depths, in places reaching the steel reinforcement. In parts are visible gravel pockets, mainly by working joints, caused by mixtures and technologies of compacting used during construction of the bridge. Lightened vaults arranged in upper arcade are also damaged on the surface. Larger defects of the concrete are mainly on the edges of walls and in the area of in-built drainage downcomers. Locally can be found places with covering concrete layer ripped off which is caused by the corrosion – increased volume of profile of corroded steel reinforcing bars. Reinforcement corrosion is visible mainly in areas of thin coverage. Remarkable defects were found in the place of dilatation of inserted deck fields, through which is water strongly leaking to the structures of lightening arcades. Reinforced nibs are markedly damaged, on which are set the inserted field and related stonework of columns. Damage of concrete in this area is reaching deepest. Stone parts of columns and abutments are

Fig. 3: Deep corrosion of the reinforcement.

- preparation of the base with silica sand blasting,
- removal of damaged covering layers in parts of corroded reinforcement, stripping, cleaning and passivation of corroding reinforcement or its completion, if necessary,
- grouting of the whole structure with micro-fine-cement (MFC),
- filling of gravel pockets and caverns,
- re-profiling,
- allover consolidation screed,
- protective paint.

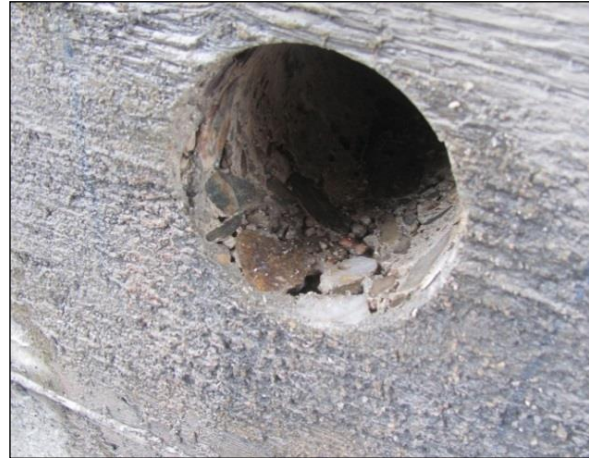
Fig. 4: Detail of the drillhole – patchy concrete.
