ANALYSIS OF DAMAGED CONNECTION PIPING

Abstract: *The following paper analyses a cracking of a superheater connection piping which occurred after a general repair. Pipes repeatedly detached in the area of welding to the collector nozzles. Connection piping was subjected to a thorough FEM analysis and flow simulation using CFD software.*

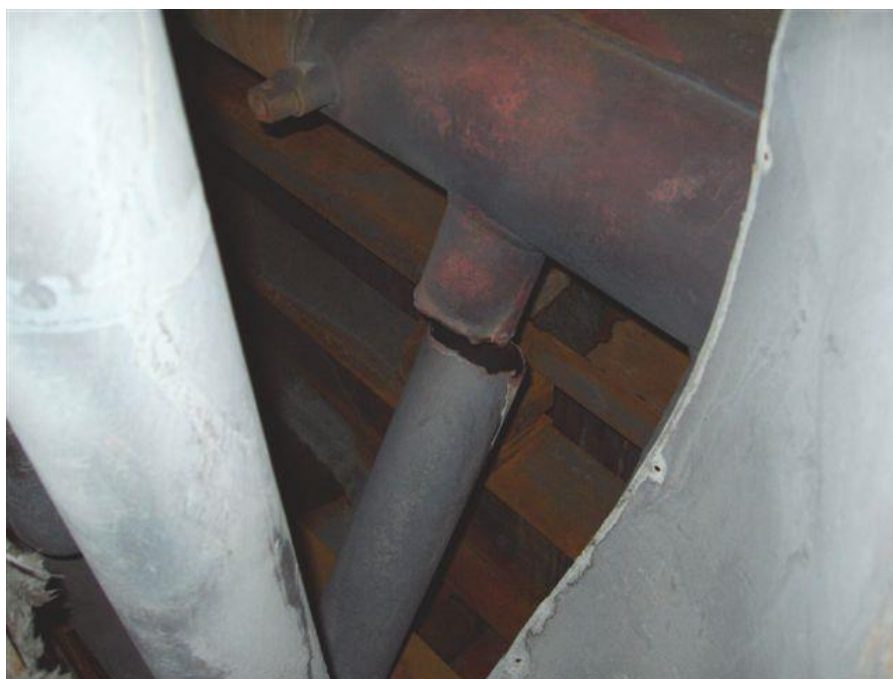
Fig. 1: Detachment of DN 100 connection piping in the area of welding to the chamber nozzle.

Based on the check analysis, no cause for the pipe cracking was identified and the design of the connection piping was verified as correct. Individual samples were afterwards taken for material analysis which also did not show any major irregularities in operation of the equipment. Failure to comply with repair technology was identified as the only possible cause of the damage. Due to inconsistencies in the drawings, two different structures may have been manufactured (in terms of dimensions) and shift of nozzles and tubes prior to welding may have reached up to 25 mm . These inconsistencies are usually

disposed of by proper fitting of the pieces during the installment process. In this case, the welding then caused serious stress in the welding area, which was manifested in the cracking of the equipment.

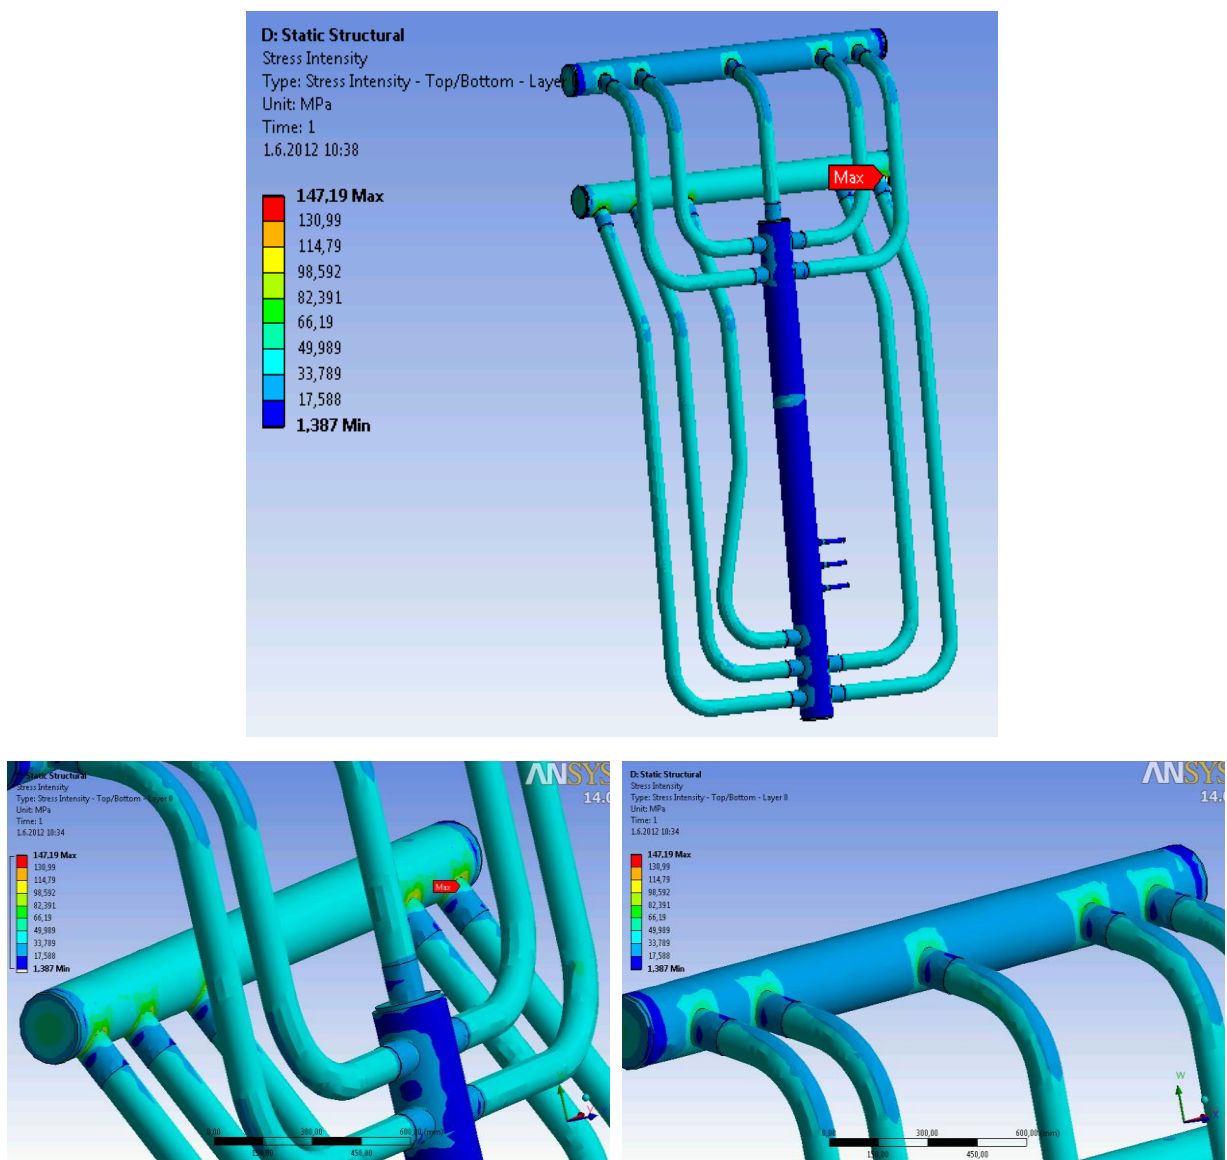
Fig. 2: Stress distribution in chambers and connection piping.

Stress values peak at 147.2 MPa, which is significantly lower than 165 MPa (Annaratton, 2007), the permissible values for membrane and bending stress (piping is made of steel 12022). Therefore, we may conclude that these normal operating conditions could not cause the damage of critical areas.

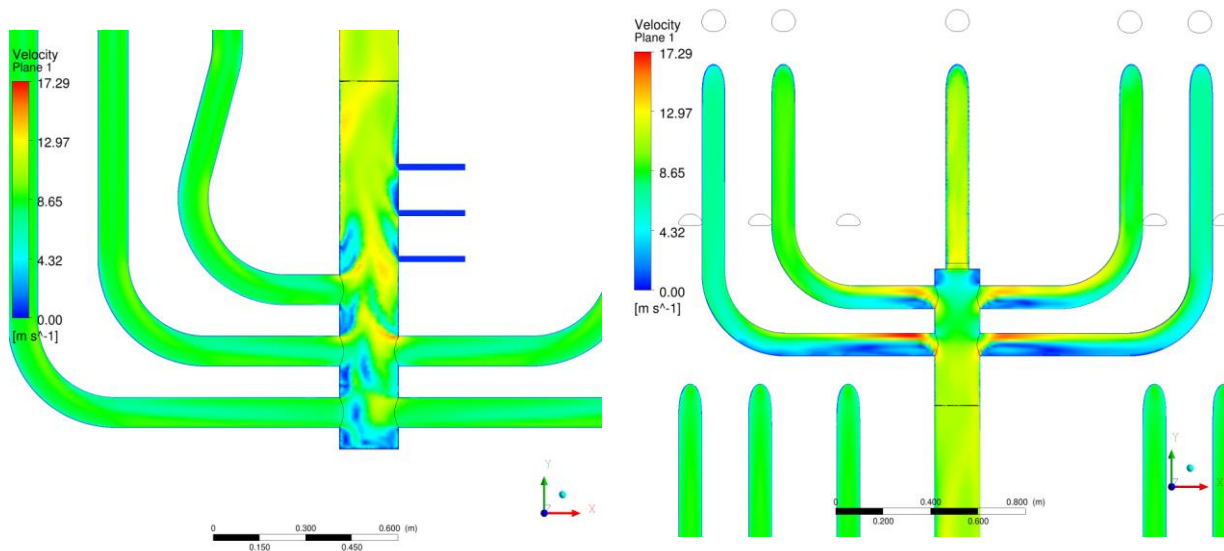
Following figure presents velocity distribution in individual parts of the connection piping. Velocity profiles indicate uneven mixing and distribution of media flows (for both saturated steam and injected condensate). These facts had a major impact on temperature distribution in the pipes.

Fig. 3: Velocity distribution during mixing of steam flows and injection of condensate (left), and steam distribution in individual branches (right).

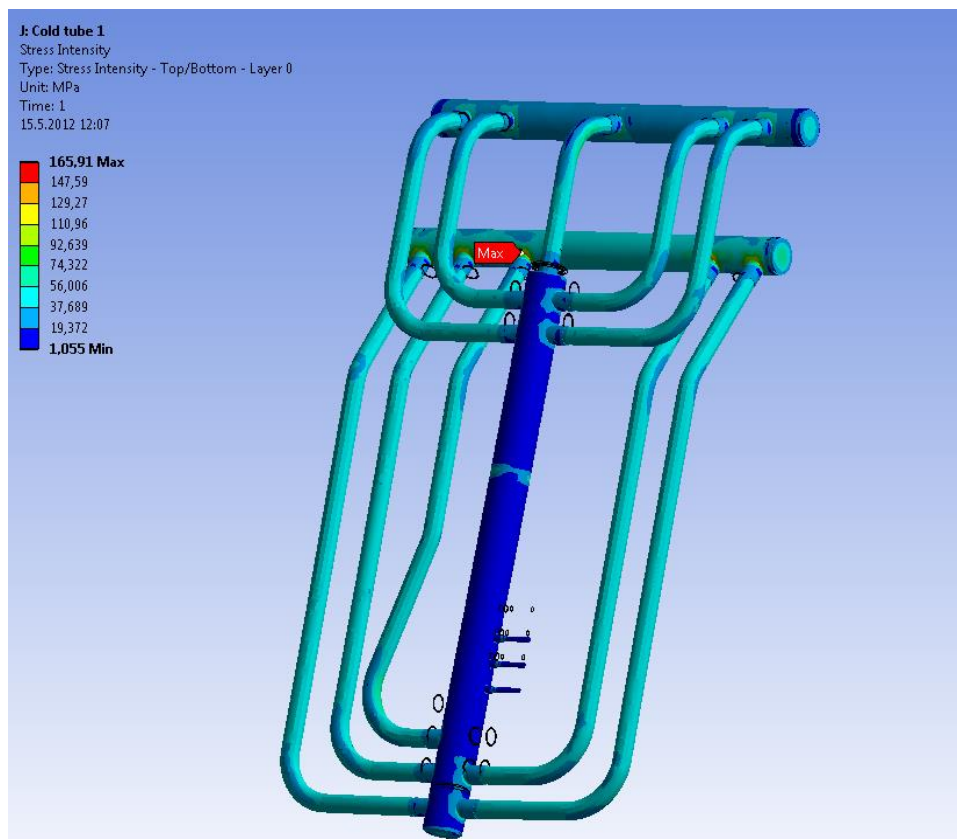
Analysis of uneven heating/cooling of connection piping was performed using acquired results. Temperatures in outer pipes differ from inner pipes and thus the outer pipes may have higher/lower temperatures. Temperature distribution was used for stress state analysis (Fluid Structure Interaction method) along with provided boundary conditions. Stress state distribution in connection piping is given in Fig. 4. Stress state peaks in the area of welding of the pipe and nozzle which are critical. Stress state reached 165.9 MPa in the critical spot, which is a permissible value. Consequently, even more specific operating conditions did not help in identification of a damage cause.

Fig. 4: Stress state distribution in connection piping.

Therefore, it is recommended that the samples are taken for material analysis, and technology compliance of the equipment repair is examined.
