SURFACE TEXTURE ANALYSIS OF A JOINT SAMPLE BY 2D AND 3D SURFACE ROUGHNESS PARAMETERS

Abstract: *This paper presents a year-long research after the aviation accident, which happened in the Czech Armed Forces. During this accident, the helicopter Mi-171 was severely damaged. This paper contains an analysis of microgeometric properties (2D and 3D) of the part of the helicopter's Mi-171 main gear, which failed during landing. The main gear contains a horizontal front strut, which is mounted to the fuselage via a coupling element in form of a cardan joint. The failure of this joint was ultimately responsible for the accident. This paper compares the qualitative properties of the joint manufactured by the Czech manufacturer and a former Soviet Union one. This paper also presents a 3D surface topography of both joint and investigates 3D surface parameters as an extension of a 2D surface parameters.*

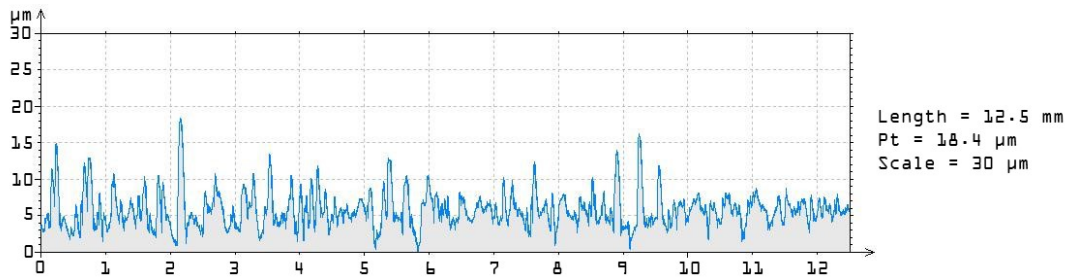
From Fig. 1 and 2. it is apparent that measured parameters have both same value of $Ra = 2.17$. While both samples have the same value of surface roughness parameter Ra , there are obvious differences in 2D profiles of surface roughness of samples 93BS (Fig. 1) and LOM (Fig. 2). Surface roughness profile of the joint sample 93BS contains significantly more peaks. Contrary to this, the surface roughness profile of the joint sample LOM contains more valleys than peaks.

Fig. 1: 2D surface roughness profile of joint sample 93BS

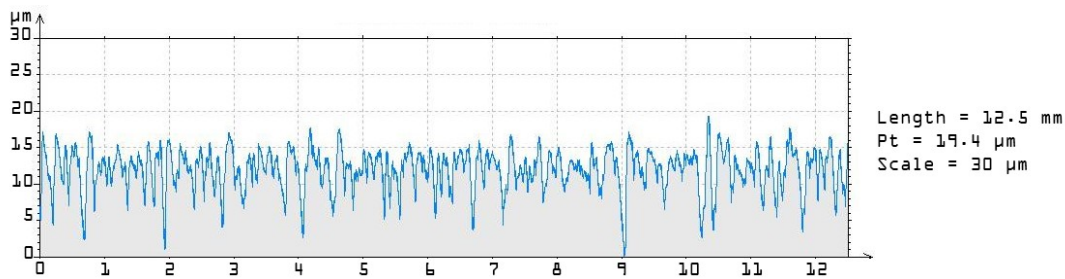
Fig. 2: 2D surface roughness profile of the joint sample LOM

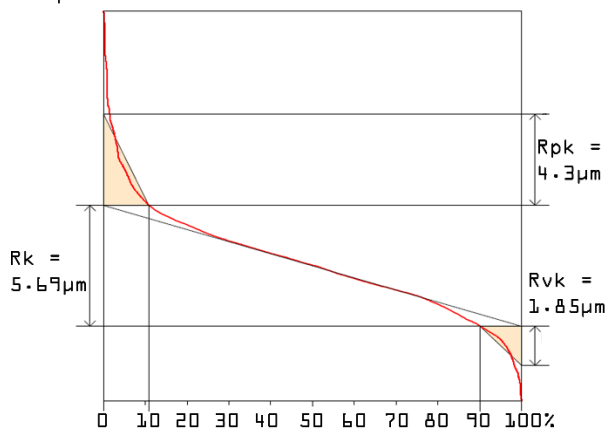
Fig. 3 and Fig. 4 all assess the Rk parameter of surface roughness. It is obvious that the base depth of the core of the surface roughness profile Rk is the same for both joint samples. Nonetheless, every other parameter reaches different values. Joint sample 93BS has the Rpk parameter larger than Rpk measured at joint sample LOM. It is possible to observe the considerably different multiplicity parameter for both joint samples. The measurement results show that the joint sample LOM has more valleys than joint sample 93BS.

that the joint sample 93BS was manufactured by forging. On the other hand, the joint sample LOM was very likely milled. These different machining technologies have an impact on the surface roughness structure, as demonstrated by the values of surface roughness parameter Rk .

Fig. 3: Rk parameter of sample 93BS

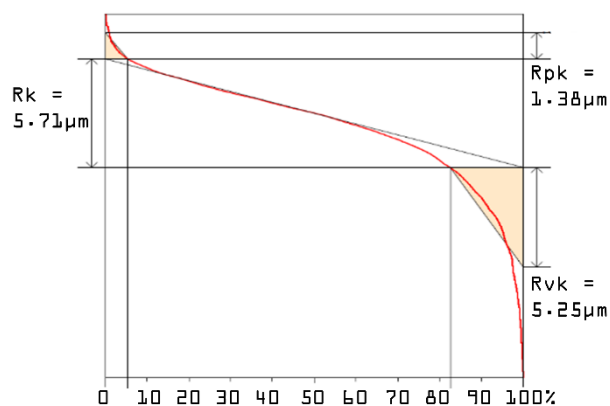
Fig. 4: Rk parameter of sample LOM

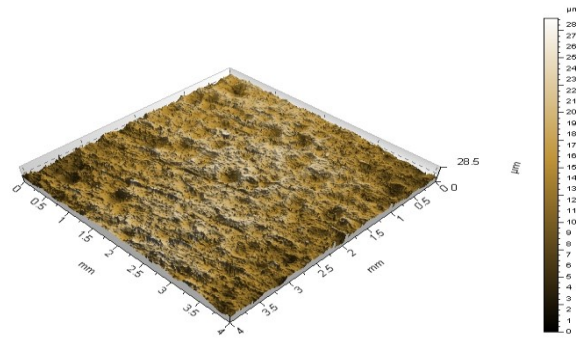
Figures 5 and 6 show 3D surface topography of joint samples 93BS and LOM. Even without close examination, it is apparent that both surfaces are different. Joint sample 93 has irregular surface structure with peaks and valleys distributed randomly along the evaluated surface area. The joint sample LOM has a more regular structure of the surface texture, where the peaks and valleys repeat periodically. There is an observable relation between this repetition and the cutting conditions of the cutting tool used during the manufacturing process. The manufacturing process of both joint samples was, therefore, different. This is confirmed by the values measured during the 3D surface topography, shown in the Table 1.

The joint sample 93BS is most likely forged, which is confirmed by the 3D surface roughness parameter Sa equal to 2.416 [μm]. The joint sample LOM was milled. The surface roughness parameter Sa of joint sample LOM is considerably larger (2.658 [μm]) than that of joint sample 93BS. It is apparent that the Czech manufacturer tried to achieve the same value of roughness parameter, but without using the proper and required manufacturing process it failed to manufacture a product with the same surface topography.

Fig. 5: 3D surface topography of the joint sample 93BS

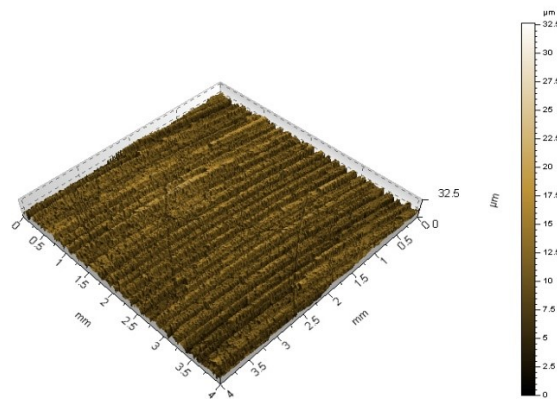
Fig. 6: 3D surface topography of the joint sample LOM
