## **FATIGUE ASSESMENT OF TURBINE BLADE BASED ON SURFACE COATING DEGRADATION AFTER EXTREME LOADING**

**Abstract:** *This study investigates fatigue damage in protective coatings and fatigue crack initiation in the substrate of the nickel-based superalloy ZhS6K, widely used in helicopter turboshaft engine turbine blades, within the framework of the damage tolerance principle. Despite its widespread use in service, the relationship between surface damage and subsurface fatigue crack development in ZhS6K has not been thoroughly investigated. The effect of coating degradation on the initiation and propagation of fatigue microcracks in the substrate material is analyzed and the damage tolerance methodology is implemented. A key contribution of this work is the identification of specific operational manoeuvres that produce high mechanical loads, leading to minor surface damage while causing major fatigue damage in the substrate. The proposed approach allows for an evaluation of blade damage that does not rely on complete load history data. This new approach can be generalized to other turbine blade materials and operating conditions.*

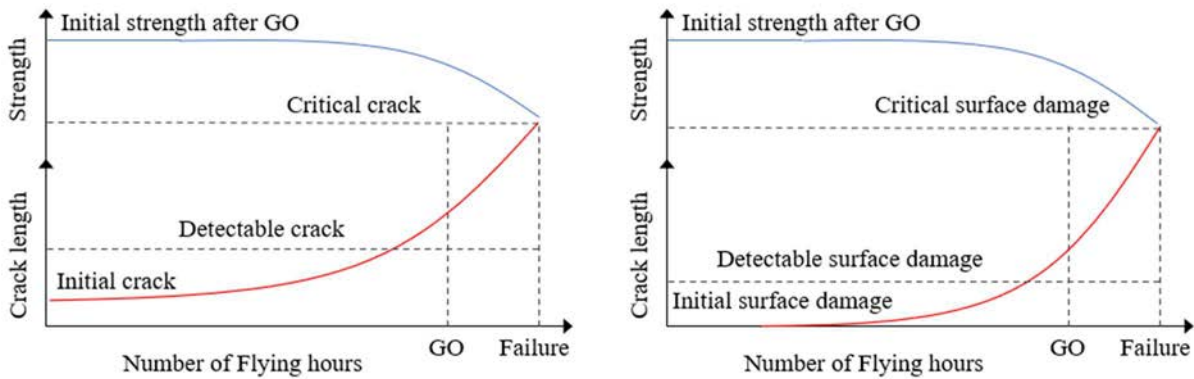
Fig. 1: Fatigue crack growth (left) and protective coating damage (right) during the service life

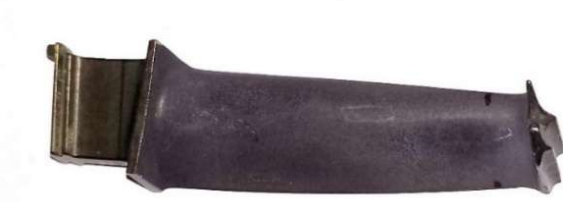
This chapter describes an experimental program focused on the turbocompressor second stage rotor blade of the helicopter turboshaft engine TV3-117 (Fig. 2). The blade structure consists of two different materials. Nickel alloy ZhS6K is the substrate material of the blade covered by a protective aluminium layer. Such designed blades should withstand aerodynamic pressure, centrifugal force, high temperature and exhaust gases. The chemical composition is defined by Swadźba (1992). The operational regimes, revolution and temperatures before the turbocompressor is defined by Furda (2016). Thirteen TV3-117 turboshaft engines and their turbine blades were subjected to visual and microscopic analysis. Digital microscopy analyses were performed using an Olympus DSX1000 optical microscope. Subsequently, the surface quality of the images was analyzed using image processing techniques in MATLAB to determine the surface integrity, defined as the percentage of residual protective coating.

*Fig. 2: The turbine blade after the service life*

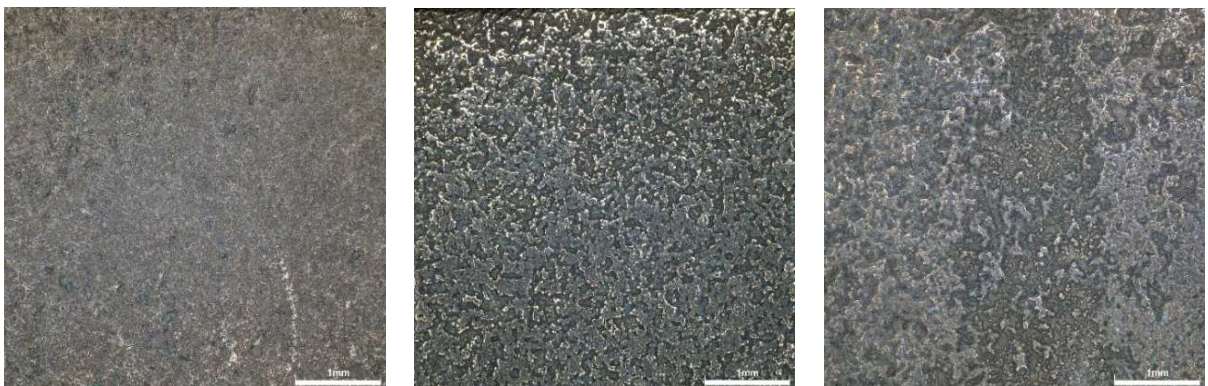
Protective coating damage is classified into three basic categories. After GO, the blade surface is smooth and free of damage. During service, the first visually detectable material loss may occur. Major damage, characterized by large areas of missing protective coating, can rapidly lead to burn-out of the substrate material (Fig. 3).

*Fig. 3: The turbine blade coating damage during the service life: initial (after GO procedure including ground test: less than 1% coating damage - left), first visual detectable damage (after 520 Flight hours: 13% coating damage - middle), major damage (after 819 Flight hours: 32% coating damage - right)*

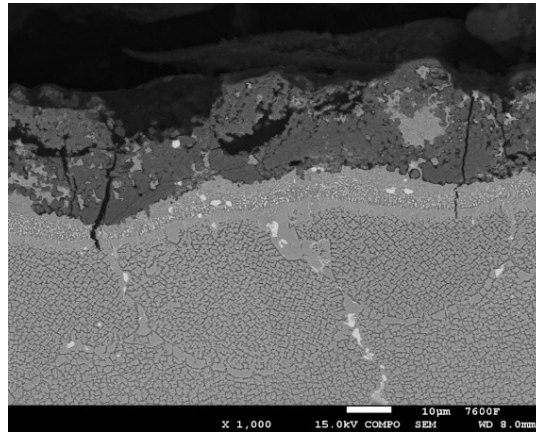
The fatigue cracks initiated from protective coating damage are shown in Fig. 4. Several fatigue cracks are across the protective coating. In some areas the protective coating is damaged. Initial fatigue microcracks are also present in the substrate material.

Fig. 4: The cross section of the turbine blade with first microcracks in the coating layer and substrate material (after 1132 Flight hours)
