ANALYSIS OF THE DIAGNOSTIC POTENTIAL THERMOVISION RESEARCH IN THE TECHNICAL CONDITION ASSESSMENT OF SPARK IGNITION ENGINES INJECTORS

Keywords: Technical state, Diagnostics, Thermovision, Injector, Fuel supply system.

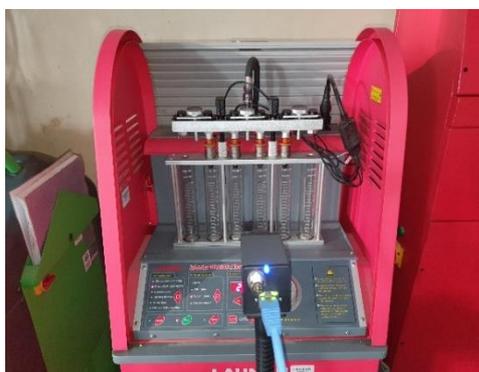
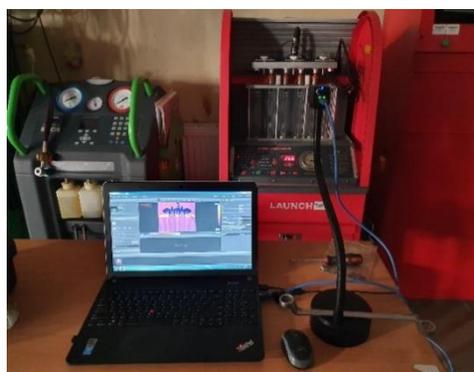
Fig. 1: Research stand.

The paper presents the implementation of the injector condition assessment procedure based on thermovision measurements. Stand tests were carried out at the stand for verification and cleaning of electromagnetic injectors LUNCH INJECTOR CLEANER & TEST shown in Fig. 1. This position enables verifications at which time duty cycle, the injector coil begins to work, the way fuel atomization, test to overflow, leak test and conduct ultrasonic cleaning of injectors.

The test stand was equipped with petrol injectors from a Nissan X-trail vehicle used in 2500 cc engines, while the test stand was equipped with a FLIR AX5 camera for continuous thermal imaging measurements.

Based on the initial tests, the test conditions were established: - ambient temperature 25 °C, - measuring distance 50 cm, - 2.4 ms injection time, - rotation speed. 800 rpm.

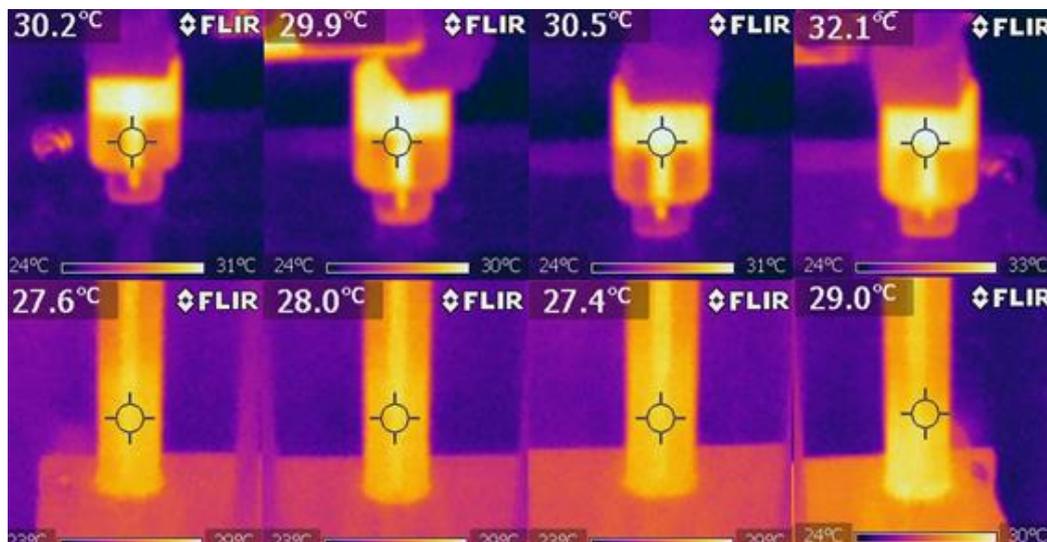
Fig. 2: Selected test results for the thermovision camera.

The results of thermographic measurements clearly confirm that there is a relationship between damage to the injector and its operating temperature. The test stand made it possible to carry out an injector cleaning test. After cleaning and overflow test, the injector showed the same parameters as efficient injectors during the first test. The results of the overflow test after cleaning are shown in Tab. 3.

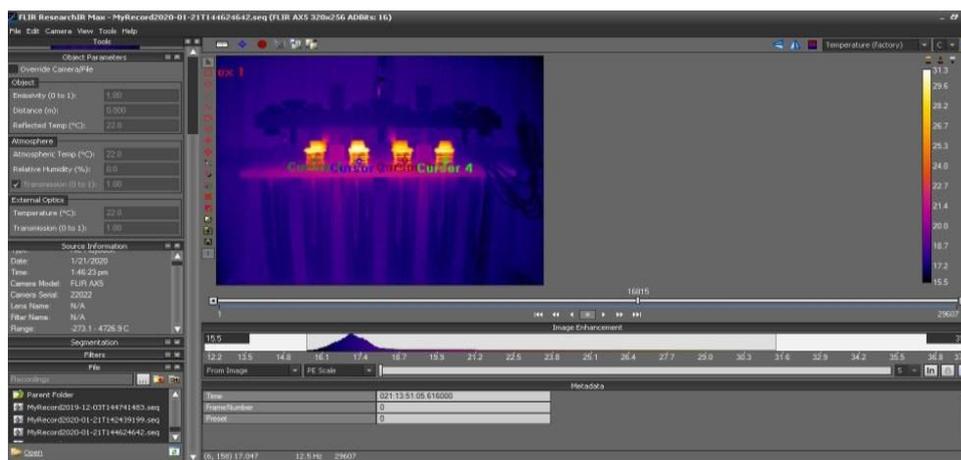
Fig. 3: The main FLIR Tools software dialog box.

Analysis of the obtained results allows to determine the accuracy of the measuring device, as well as to verify the dependence of the temperature gradient increase at the measuring points. The test results presented in the tables are measurements at the selected point. Detailed analysis requires propagation of thermal energy flow in the injector based on the analysis of thermographic images. Fig. 2 presents selected results of thermovision examinations of injectors. FLIR Tools software was used to analyse thermographic images. The main software dialog window is shown in Fig. 3.
