DAMAGE IDENTIFICATION ON STRINGERS BY MODAL ANALYSIS

Abstract: *The paper is dedicated to damage identification on stringers of a steel truss bridge. Different damage types on the railway bridge, like cracks, rust, permanent deformation and so more are well known but rarely identified. One of the most common type of the damage is loss of material in stringer flanges caused by rust. In practice different methods for damage identification can be used. This paper focuses on higher mode shape and eigenfrequencies of stringer web vibration, which are more sensitive to damage locations. Parametric study has been performed where the effects of different damage locations along the stringer has been investigated. Later, changes in local eigenfrequencies and modal shapes of the stringer web have been analysed with respect to different location of damage. In global analysis identifying of corresponding higher frequencies is very difficult, because the values of the eigen modes are quite close to each other. Therefore, an original subroutine has been prepared that helps to find the corresponding modal shapes of the substructure used for damage identification. Using this method it is possible

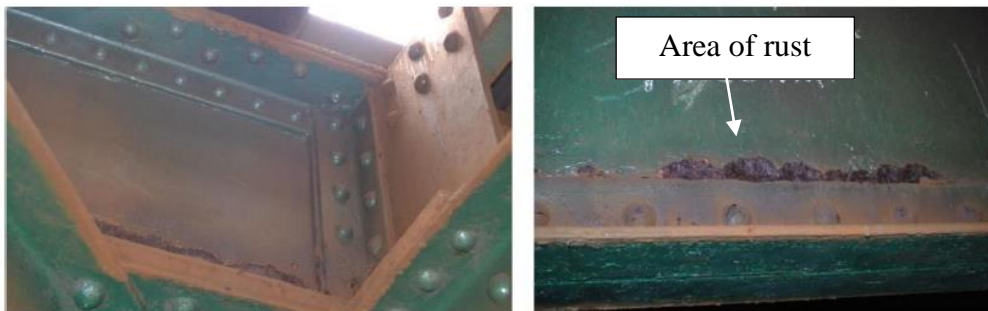
Fig. 1: The most common type of damage on steel bridges. (Rust on wall).

Currently, there are many old railway bridges in Slovakia and Czech Republic, which are at the end of their lifespan. Therefore, many researchers are doing diagnostics to determine their condition. It is possible to identify different types of damage and failures that affect the response of the structure. According to Vičan (2016), the most common damage is rusting of some parts of stringer, loosening of fasteners or permanent deformation. The damage (rust on wall-flange connection) has been assumed because it is one of the most common damage on this type steel bridges (see Fig. 1).

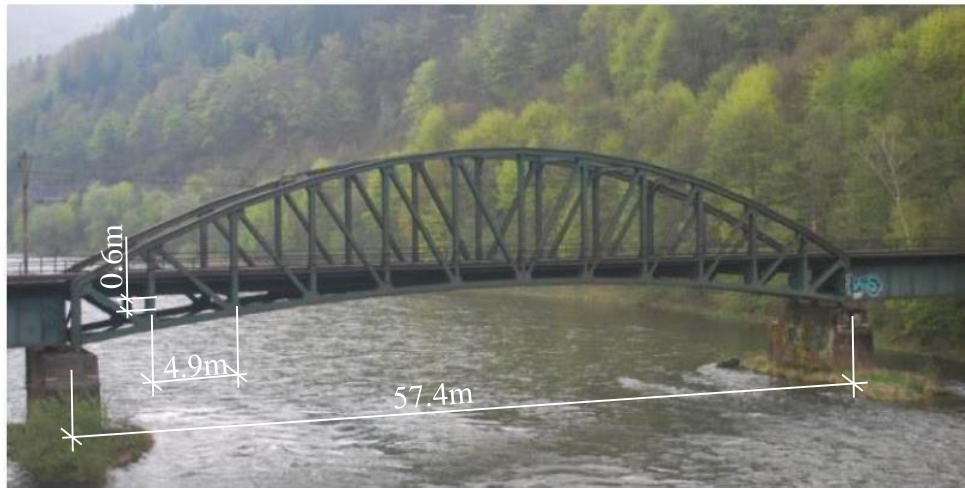
Fig. 2: Arch bridge over river Váh near Strečno.

For purpose of this analysis, railroad bridge over the river Váh near Strečno has been investigated. The bridge consists of a truss arch bridge with a span of 57.4 m see Fig. 2. The length of stringers is 4.9 m and its height is 0.6 m.

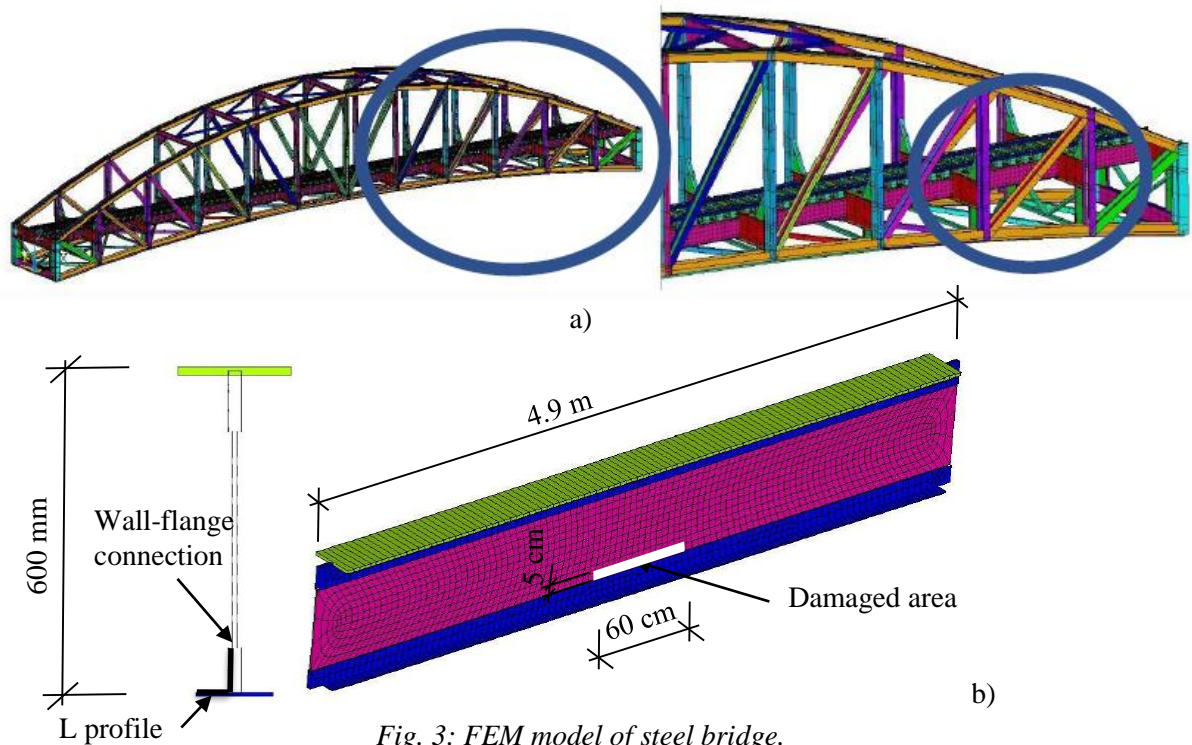
Fig. 3: FEM model of steel bridge.

A detailed numerical model of the bridge was using FEM software (ANSYS) see Fig. 3a. To study the parametric damage, it was necessary to create the most accurate model of the bridge deck, especially stringers Fig. 3b. Parametric study of damaged stringer, in the second field of the bridge, has been carried out.

It was assumed that the damage is located on the wall-flange connection above the L profile see Fig. 3b. Damage has been simulated by change the material properties – Young modulus. The modulus of elasticity was gradually reduced up to 10 %. Damage has been modelled as 60 cm long and 5 cm width damaged area with reduced material properties. The location of his damage was gradually shifted along the x-axis by 30 cm overlap of previous position. Everything has been done in cycle automatically. This cycle resulted in nine position of damage. Each of these positions affected the local eigenfrequencies and modal shapes of the stinger.

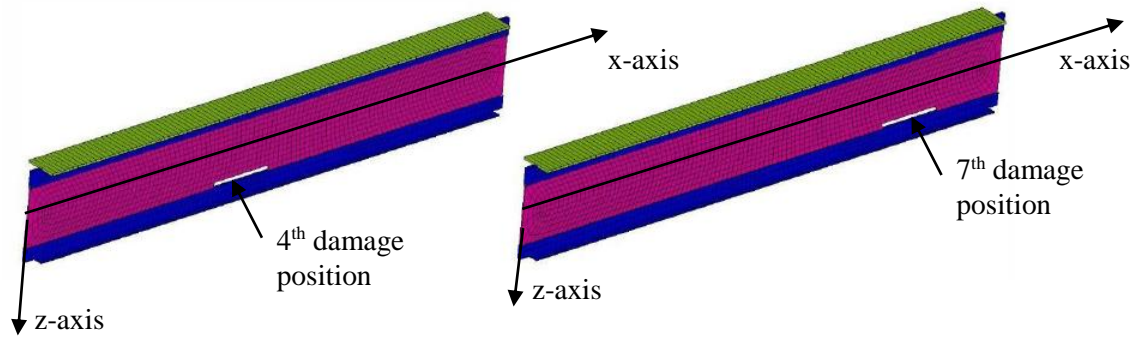
Fig. 4: Assumed damage of stringers.

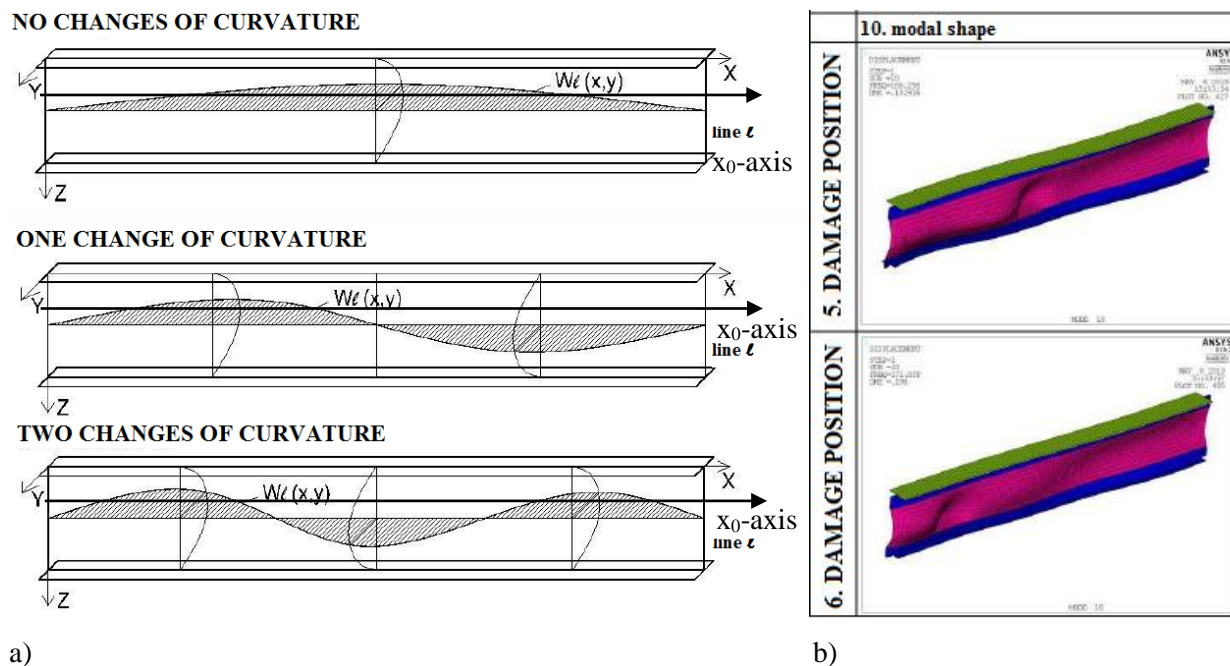
Fig. 5: Subroutine for finding modal shape.

As mentioned above, searching for higher mode shapes in the global analysis of the whole bridge is time-consuming and difficult (because of changes the numbers of the modes), therefore a subroutine was prepared for searching the corresponding shapes. This program can find changes in the curvature of the function $W_\ell(x, y)$. The function $W_\ell(x, y)$ represents the horizontal displacement of a certain line see Fig. 5 on the left. The height of this line can be set as needed. The number of changes in curvature determines the mode shape. Based on the mode shape, the relevant eigenfrequency can be determined after damaging of the stringer.
