## CYCLIC LOADING OF MASONRY WALLS AND ITS ANTI SEISMIC REINFORCING

**Abstract:** *The damage of structural masonry walls is one of the most widespread harming injuries and cause of loss of serviceability and seismic capacity for a building. Therefore a research into possibilities which would improve these characteristics have been carried out within the 7<sup>th</sup> EC Framework programme project NIKER. The retrofitting approach is constrained by conservation requirements of minimum interventions which should not severely change the structural behavior and the structural appearance, and should prefer solutions without a necessity of total structural disassembling. This article provides an overview about the research that led to applications of the steel wire ropes and geo-nets onto adobe brick walls.*

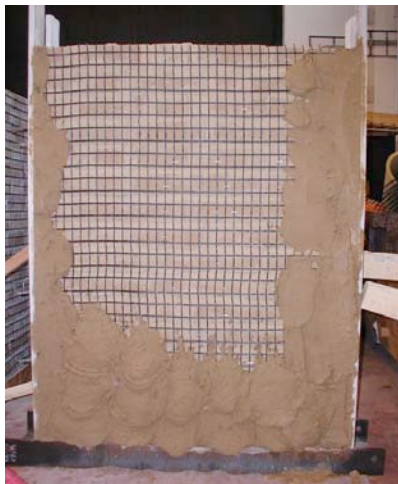
Fig. 2: Adobe brick wall with geo-nets (ABW\_3)

For the reinforced specimens a polyethylene TENCATE geo-nets and polypropylene TENAX geo-nets externally applied onto the wall surfaces have been used. After they have been mechanically fastened, the walls were rendered with about 2 cm thick plaster made with lime mortar.

In Figures 2 – 3 the tested walls are showed onto which the reinforcement nets were applied. Figure 4 shows a detail of the anchoring (reinforcement with wire ropes).

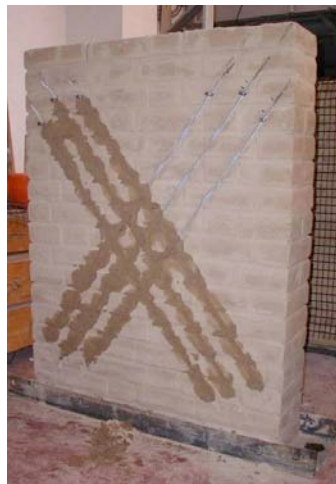
Fig. 3: Adobe brick wall with a steel wire ropes (ABW\_2)

The second reinforcement method is represented by means of steel wire ropes placed diagonally and in two directions on the wall surfaces. The wire ropes were installed in three grooves per direction previously produced on the surface of the wall and adequately anchored at their extremities by means of mechanics fasteners.

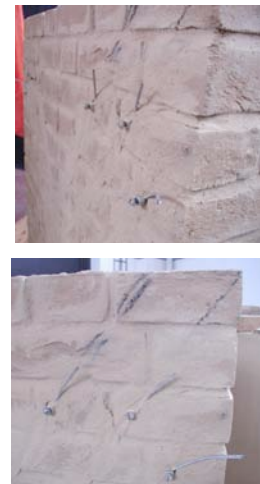
Fig. 4: Connection detail (ABW\_2)

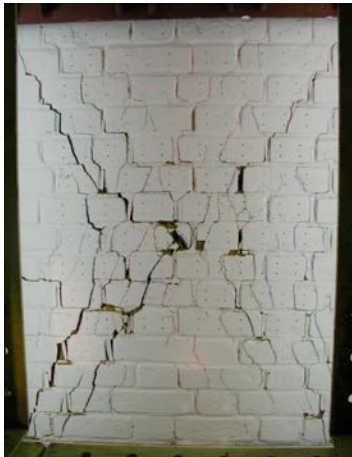
Fig. 7: Crack pattern at failure of the plain masonry control wall under a combination of vertical compression and cyclic shear.

Typical failure cracking of a plain masonry wall without plaster loaded by combined uniformly distributed vertical static stress and a horizontal cyclic load is shown in Figure 7. The development is highlighted by means of colouring of the cracks.

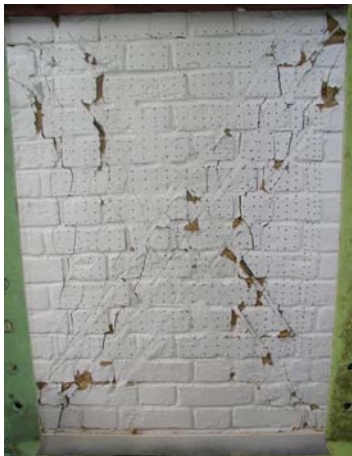
Fig. 9: Crack pattern at failure of the plain masonry control wall under a combination of vertical compression and cyclic shear.

The adobe brick wall reinforced by means of steel wire ropes also has been tested. In Figure 9 the crack pattern upon failure of the specimen is shown. In case this kind of reinforcement is adopted an important improvement in terms of resistance can be attained. The wall reinforced by means of this technique behaves in a quite compact manner since the wire ropes play a very effective role in sewing up the cracks and keeping the masonry blocks together. Some cracks can appear along the mortar joints in the surroundings of the reinforcement and, in general, there is a good redistribution of the stresses and a more widespread crack pattern compared to the unreinforced wall.

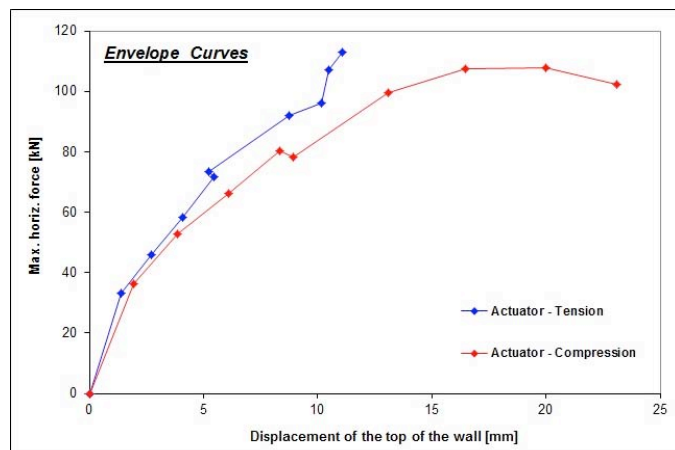
Fig. 10: Envelope curves for reinforced adobe wall by wire ropes (ABW\_2).

Another important aspect brought to light by the experiments is related to the damage due to the possible out-of-plane of the reinforcement. In particular, the wire ropes are placed quite superficially in grooves made on the wall faces and just plastered with mortar. Since during the application of cyclic horizontal loading both direction of reinforcement can be subjected alternatively to compression, causing the tendency to the ropes to go out of the grooves. However, since the reinforcement is made by steel wire, during tension phase they can easily be able to continue to be effective, involving only superficial damage of the wall. The envelope curves for the wall reinforced by the wire ropes is depicted obtained from the cyclic curves are plotted in Figure 10.

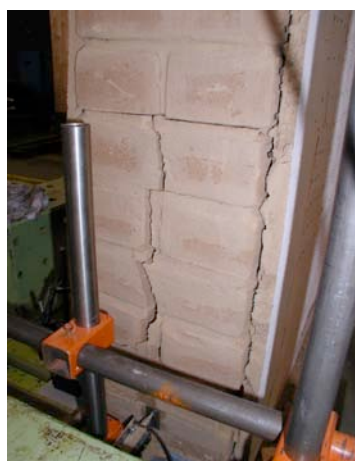
Fig. 11 - Evidence of the detachment of the plaster from the wall surface.

It is, thus, evidenced the typical behaviour of walls reinforced by means of this technique. It is noticed that the cracks visible on the surface represent a combination of two sets of damages: masonry cracks and cracks which occur in the plaster only and originate from the differential movement of the geo-nets mesh. It is observed that compared to the typical crack pattern usually found in plane masonry walls, the case of the wall strengthened with reinforced mortar layer present a more widespread and diffused crack pattern. In fact, when unreinforced masonry wall is subjected to a combination of vertical pre-stress and horizontal cyclic load cracks are localized in the two diagonal lines of the walls evidencing the typical X-shaped pattern. The application of the reinforced mortar with geo-nets to the surfaces of the wall has also the effect to redistribute the stresses originated upon loading along the two diagonal lines of the wall and, thus, to spread the pattern over a wider area of the wall surface. An important aspect to be taken into account in the evaluation of the effectiveness of this kind of reinforcement is the interface behaviour between the external reinforcement and the masonry substrate to which it is applied represented by the wall. Since the reinforced mortar layer applied on the wall surfaces is slightly thin (1.5 ÷ 2.0 cm), and due to the different stiffness compared to the substrate, the out-of-plane forces can detach it. The experimental evidence of the detachment of this layer is much more evident when the difference in stiffness is larger. This happens particularly in the cases of application to this kind of reinforcement to clay bricks walls, while in case of adobe walls it is not so evident since the plaster has been made of the same material of the bricks. In Figure 11 it is shown a detail of the detachment of the plaster from the surface of the masonry wall.

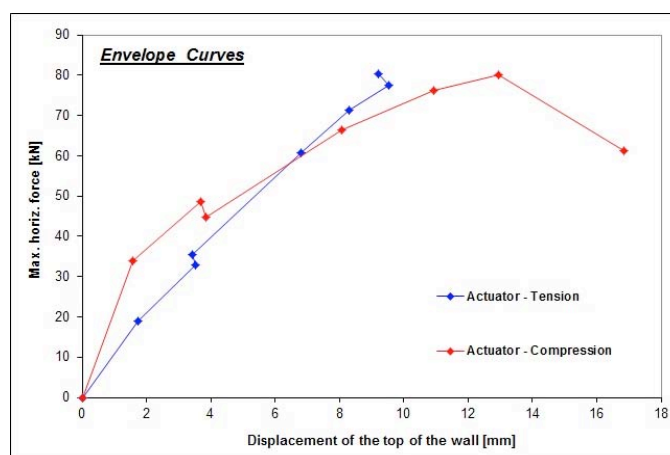
Fig. 12 - Envelope curves for reinforced adobe wall by the geo-nets PET (ABW\_3).

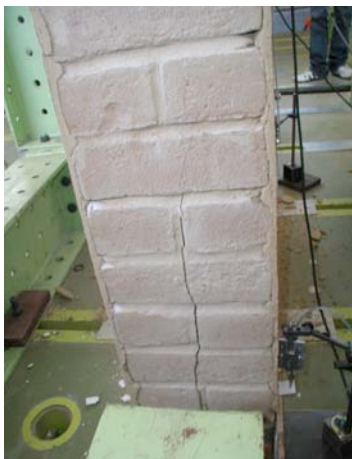
Fig. 13: Vertical crack in the wall thickness

area of the panel with detachment of mortar plaster and a concentration of damage at the base corners of the specimen were observed. Also in this case, as already observed in the case of the undamaged wall strengthened with reinforced mortar layers, the wall experienced the detachment of the mortar. However, in this case the major detachment is in the central area of the specimen. For higher values of the driven displacement, the out-of-plane detachment of the plaster in the lower part of the wall close to the corners was also observed. Moreover, due to a very high stress concentration in that area, a significant crack appeared and spread in the wall thickness, as reported in Figure 13.

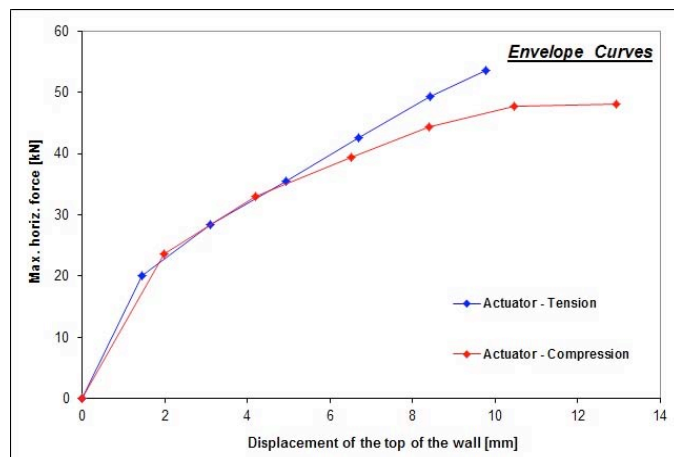
Fig. 14: Envelope curves for retrofitted adobe wall by the geo-nets PET (ABW\_4).

In the Figure 14 the global envelope curve of the maximum force and corresponding displacement at the top of the wall cyclic for particular loading are showed.

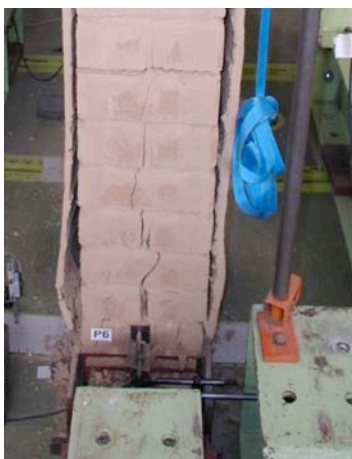
Fig. 15: Vertical crack in the wall thickness

The further tested reinforcement of adobe walls was the reinforcement by PP geo-nets. The nets were attached to the both surface of the wall by means of steel staples shot by pneumatic pistol. Figure 15 presents the crack pattern at failure registered for the wall with reinforced plaster by PP geo-nets after test. The behaviour of this reinforced wall is the same as the behaviour of the wall ABW\_3. It is, thus, evidenced the typical behaviour of walls strengthened by means of this technique. Also in this case the wall experienced the detachment of the mortar. However, in this case the major detachment is in the central area of the specimen. For higher values of the driven displacement, the out-of-plane detachment of the plaster in the lower part of the wall close to the corners was also observed. Moreover, due to a very high stress concentration in that area, a significant crack appeared and spread in the wall thickness. The cracks in the case ABW\_3 and ABW\_5 are similar. The envelope curve of the maximum horizontal force and the correspondent displacement obtained from the cyclic curves for each step of loading are plotted in Figure 16.

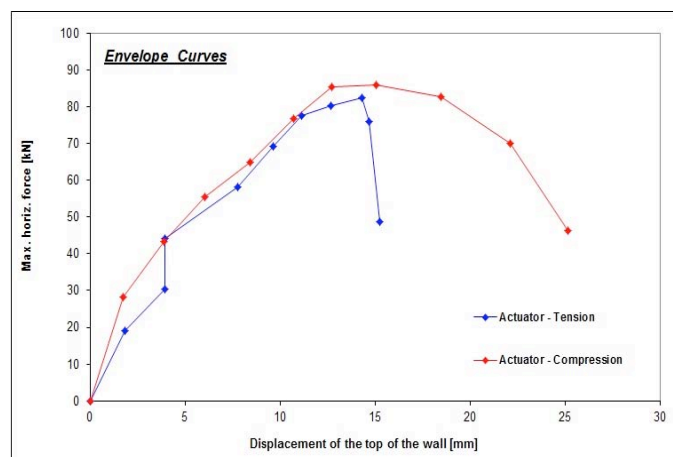
Fig. 16: Envelope curves for retrofitted adobe wall with geo-nets PP (ABW\_5).

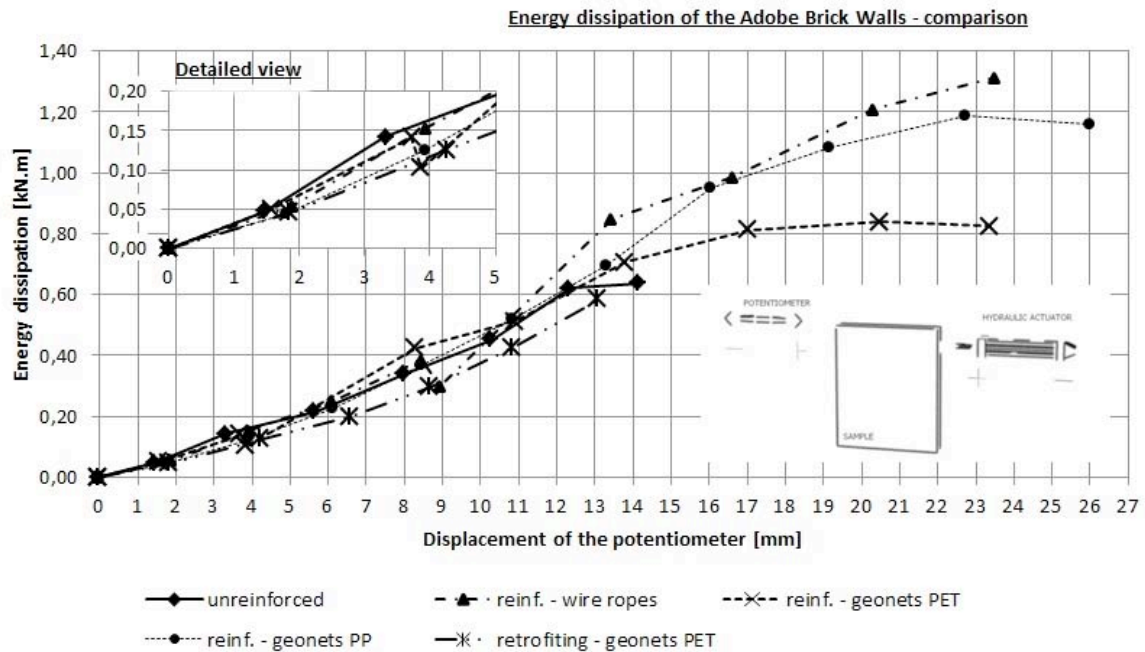
Fig. 20: Comparison of the energy dissipation

The next comparison is by the energy dissipation. Energy dissipation was calculated from the area of a hysteresis loop. The area was determined from one cycle in a given step. The tests carried out here provide several important results for adobe brick walls. It has been shown that steel wire ropes on an adobe wall surface increase significantly the energy dissipation of the wall. The effectiveness of the system is evident also in terms of increment of the displacement capacity of the wall. This type of reinforcement is very cheap in costs and the most efficient from the point of view of the strengthening from the all used method. It was observed that the application of the reinforced mortar layers onto the wall's surfaces allows the specimen to reach a higher value of energy dissipation. Moreover, an increment in terms of ductility is also registered. Geo-nets have also a better ratio of strength to the strength of brick and, therefore, it is favourable to apply them. Unlike in the case of steel wire ropes, there is not such a danger of pulling out the reinforcement in the out-of plane. Comparing the energy dissipation of the retrofitted wall by means of geo-nets (PET) with the unreinforced adobe brick wall it can be observed that the stiffness of the retrofitted wall is lower than the stiffness of the control wall, even after the intervention. Comparing the energy dissipation of the retrofitted wall by means of geo-

nets (PET) with the unreinforced adobe brick wall it can be observed that the stiffness of the retrofitted wall is lower than the stiffness of the control wall, even after the intervention. Comparing the force-displacement curve of the reinforced wall by means of geo-nets (PET) with the reinforced wall by means of geo-nets (PP) it can be observed that the strengthening with mortar reinforced with both geo-net is similar. However, energy dissipation is greater in the use of geo-nets (PP), see Figure 20.
