## THE EVALUATION OF THE PROCESS OF SURFACE REGENERATION AFTER LASER CLADDING AND FACE MILLING

**Abstract:** *This elaboration presents the results of experiments concerning milling of surfaces exposed to laser cladding. The aim of this elaboration has been to conduct the quality evaluation concerning the process of regenerating a flat surface of sheet metal made of steel C 45 through laser cladding and face milling. The assessment of the results of the regeneration process has been conducted on the basis of selected parameters of the geometric structure of the regenerated surface and the identification of surface defects.*

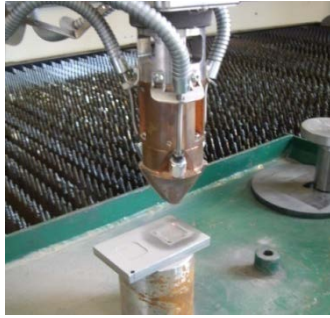
Fig. 2. Head used for cladding and the process of cladding (Wijas & Nowakowski, 2015)

| PARAMETERS OF CLADDING: |
| Feed: 1000, mm/min |
| Width of the laser beam for deposition: 3 mm |
| Laser power: 35 % Pmax |
| Frequency: 20000, Hz |
| Gas flow Ar: 12, l/min |
| Rotations of the feeder: 3, 1/min |
| Gas flow of the feeder He: 3, l/min |

The second stage of research included filling the material defect of the sample through laser cladding by using LASERCELL 1005 manufactured by Trumpf (fig. 2) facilitated with a powder conveyor produced by GTV (Sęk & Tofil 2014, Harnicarova et al. 2012). During the process of laser cladding, the powder used was metal powder PMNi of hardness of 57 HRC and granulation of 100–160 µm. In order to replenish the defect of 0.75 depth, 5 layers of clad overlay were applied. After the test, it appeared that such a number of layers is insufficient. Thus, two more layers were applied (fig. 3).

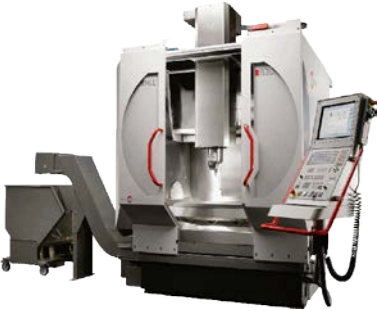
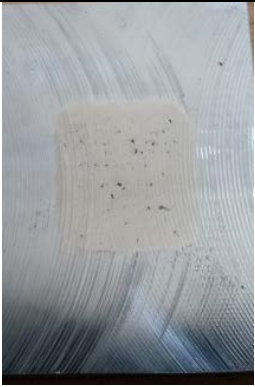
Table 1. View of the machine and the sample after milling with a milling head

| General view HERMLE B300 | Head<br>R245-080Q27-12M | Parameters of<br>machining | Sample after machining |
| | | $v_c$ , 215 m/min<br>$n$ , 855 rotations/min<br>$f_z$ , 0.1 mm/cutter<br>$f_z$ , 513 mm/cutter<br>$a_p$ , 0.5 mm<br>$a_e$ , 50 mm | |
| | Plate<br>R245-12T3M-PL4230 | | |

The fourth stage was the process of face milling, with the usage of milling center HERMLE B 300 (table 1), of the clad surface that was conducted in order to achieve a flat surface. The research used the

head R245-080Q27-12M produced by Sandvik Coromant that was facilitated with plates of type 245-12T3M-PL4230. The sample was milled with the feed of a cooling and lubricating liquid.
