ANALYSIS OF THE DIAGNOSTIC POTENTIAL THERMOVISION RESEARCH IN THE TECHNICAL CONDITION ASSESSMENT OF SPARK IGNITION ENGINES INJECTORS

Abstract: *The paper presents an analysis of the possibilities of implementing thermographic tests in the process of assessing the technical condition of spark-ignition internal combustion engines. Presented method is an innovative approach to diagnosing the condition of injectors used in spark-ignition internal combustion engines. Presented non-installation method of assessment injectors technical state uses measurements of accompanying processes such as heat generation by their working elements. The use of thermovision cameras allows direct verification of the injectors state. The work is a continuation of the implementation of thermovision tests in the assessment of the technical condition of internal combustion engines implemented by the authors.*

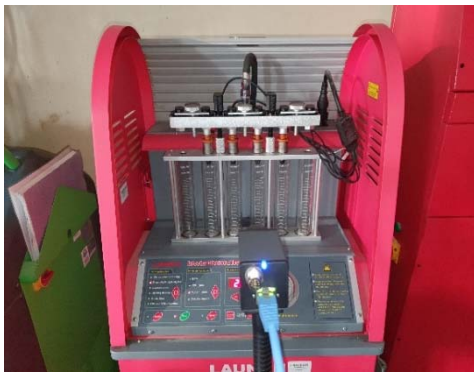
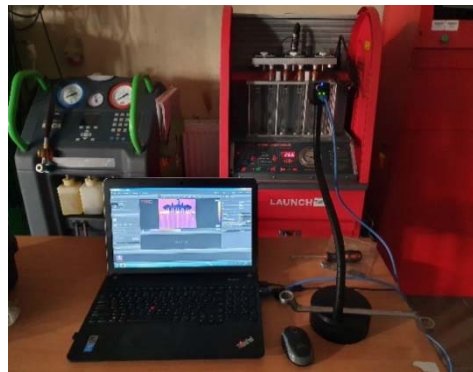
Fig. 1: Research stand.

The paper presents the implementation of the injector condition assessment procedure based on thermovision measurements. Stand tests were carried out at the stand for verification and cleaning of electromagnetic injectors LUNCH INJECTOR CLEANER & TEST shown in Fig. 1. This position enables verifications at which time duty cycle, the injector coil begins to work, the way fuel atomization, test to overflow, leak test and conduct ultrasonic cleaning of injectors.

The test stand was equipped with petrol injectors from a Nissan X-trail vehicle used in 2500 cc engines, while the test stand was equipped with a FLIR AX5 camera for continuous thermal imaging measurements.

Based on the initial tests, the test conditions were established: - ambient temperature 25 °C, - measuring distance 50 cm, - 2.4 ms injection time, - rotation speed 800 rpm. First, the condition of the injectors was verified by overflow test. The measurements showed that the injector No. 4 gives much less fuel, which may indicate that it is dirty. The measurement results are shown in Tab. 1.

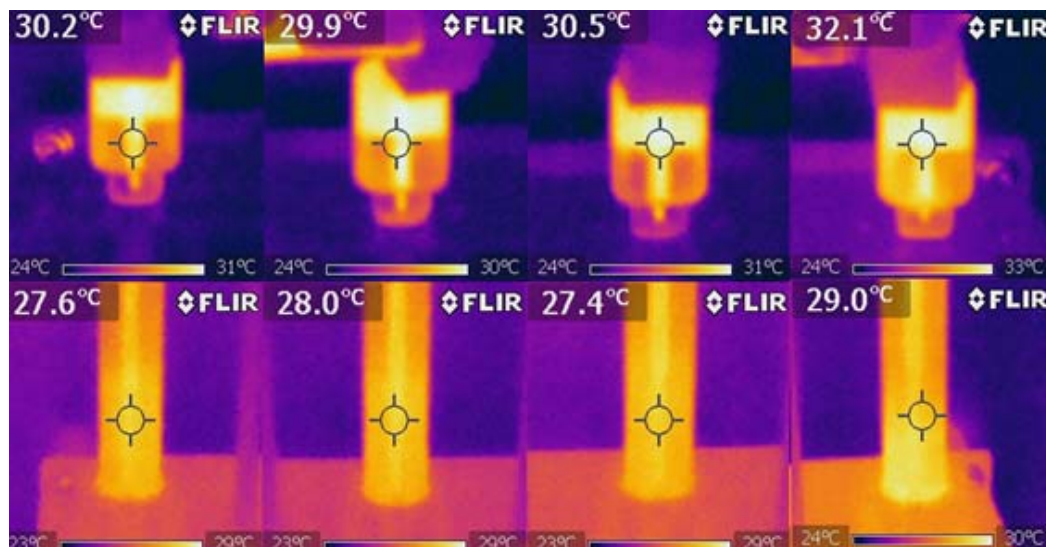
Fig. 2: Selected test results for the thermovision camera.

Then, thermographic measurements were carried out during the operation of the injectors according to the following methodology. The injection system was running for 20 min. During the work, the injector temperature was read every 5 minutes. Readings were taken in three measurement series; the results are presented in Tab. 2.

The results of thermographic measurements clearly confirm that there is a relationship between damage to the injector and its operating temperature. The test stand made it possible to carry out an injector cleaning test. After cleaning and overflow test, the injector showed the same parameters as efficient injectors during the first test. The results of the overflow test after cleaning are shown in Tab. 3.

Analysis of the obtained results allows to determine the accuracy of the measuring device, as well as to verify the dependence of the temperature gradient increase at the measuring points. The test results presented in the tables are measurements at the selected point. Detailed analysis requires propagation of thermal energy flow in the injector based on the analysis of thermographic images. Fig. 2 presents selected results of thermovision examinations of injectors. FLIR Tools software was used to analyse thermographic images. The main software dialog window is shown in Fig. 3.
