DAMAGE IDENTIFICATION ON STRINGERS BY MODAL ANALYSIS

Abstract: *The paper is dedicated to damage identification on stringers of a steel truss bridge. Different damage types on the railway bridge, like cracks, rust, permanent deformation and so more are well known but rarely identified. One of the most common type of the damage is loss of material in stringer flanges caused by rust. In practice different methods for damage identification can be used. This paper focuses on higher mode shape and eigenfrequencies of stringer web vibration, which are more sensitive to damage locations. Parametric study has been performed where the effects of different damage locations along the stringer has been investigated. Later, changes in local eigenfrequencies and modal shapes of the stringer web have been analysed with respect to different location of damage. In global analysis identifying of corresponding higher frequencies is very difficult, because the values of the eigen modes are quite close to each other. Therefore, an original subroutine has been prepared that helps to find the corresponding modal shapes of the substructure used for damage identification. Using this method it is possible

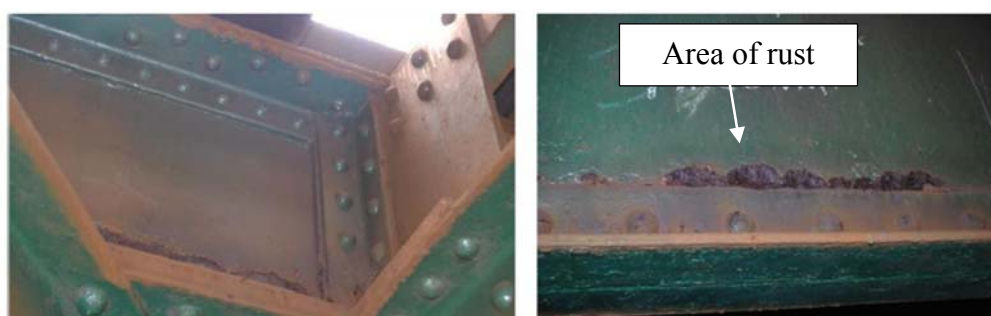
Fig. 1: The most common type of damage on steel bridges. (Rust on wall).

Currently, there are many old railway bridges in Slovakia and Czech Republic, which are at the end of their lifespan. Therefore, many researchers are doing diagnostics to determine their condition. It is possible to identify different types of damage and failures that affect the response of the structure. According to Vičan (2016), the most common damage is rusting of some parts of stringer, loosening of fasteners or permanent deformation. The damage (rust on wall-flange connection) has been assumed because it is one of the most common damage on this type steel bridges (see Fig. 1).

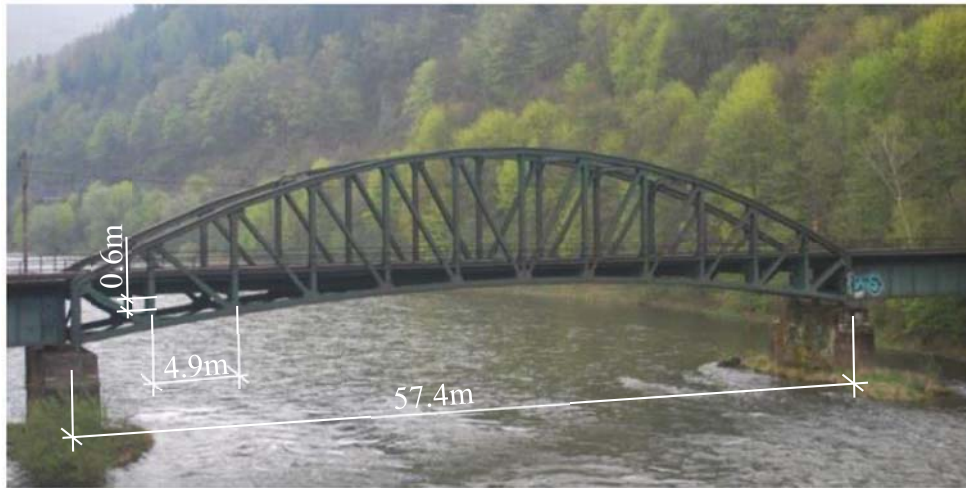
Fig. 2: Arch bridge over river Váh near Strečno.

For purpose of this analysis, railroad bridge over the river Váh near Strečno has been investigated. The bridge consists of a truss arch bridge with a span of 57.4 m see Fig. 2. The length of stringers is 4.9 m and its height is 0.6 m.
