CHARACTERISTIC OF DAMAGE TO THE STRUCTURAL ELEMENT BY CREATING ITS “DEGRADATION PROFILE”

J. Frankl^{*}

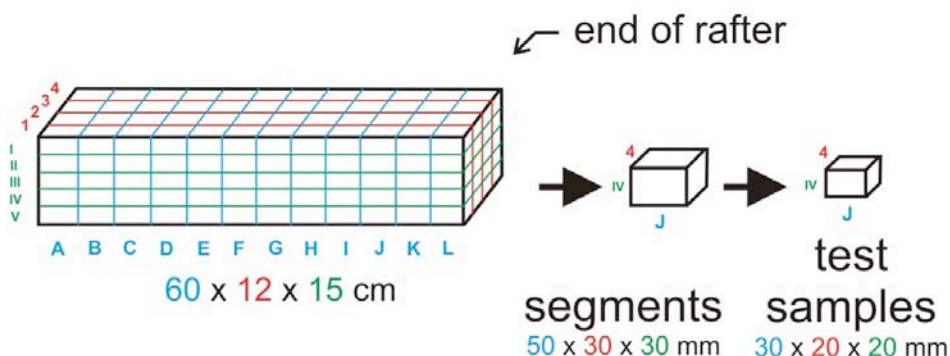
With regards to the required size of the test specimens, the dimensions of the tested wooden element and the technological capabilities (handling and woodworking machines), the division of the element "roughly" into a regular network of 12 x 5 x 4 segments of the size of approx. 45 x 25 x 25 mm was selected. More exact test samples of the required size of 20 x 20 x 30 mm were then made from individual segments, where possible. The difference in the sizes of segments and test samples covered losses during the processing (offcut) and allowed to partly offset the natural wood defects (knots, cracks). The division of part of the element by transverse and longitudinal cuts into individual segments and the production of test samples is clear from Fig. 2. Given the extensive damage to some parts and due to the natural defects of the wood, it was not possible, despite this measure, to prepare test samples from some of the segments Fig. 3.

Fig. 2: Division of parts of the rafter into individual segments, their marking and the scheme of the production of test samples.

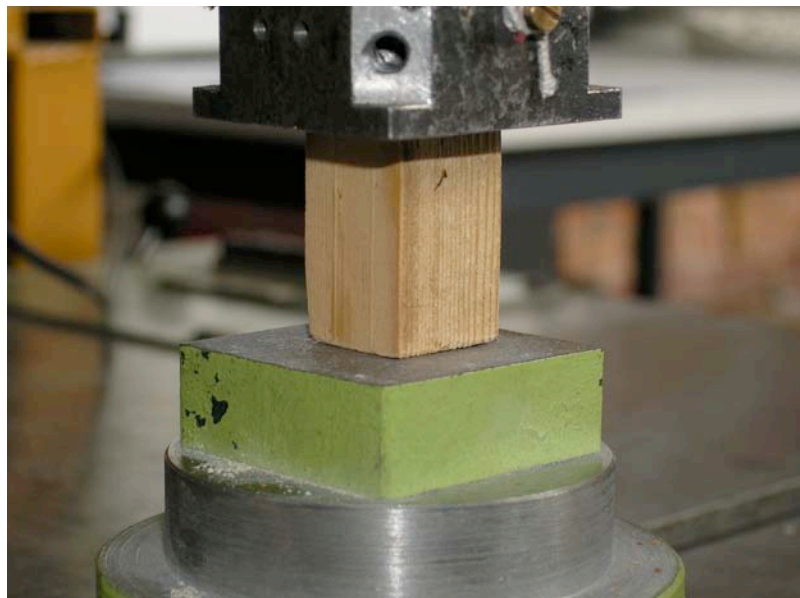
In test samples prepared from individual segments, a test of the limit of compression strength in the direction of fibres was performed. The test was performed using the Testatron load testing apparatus as per the CSN 490110 Czech National Standard. Before the tests, humidity of test samples was adjusted in a climatic chamber to the prescribed 12 %. The testing apparatus and examples from the test of the samples are shown in Fig. 4.

Fig. 4: Tests of mechanical properties of the wood - test of the compression strength in the direction of fibres.
