Helical Reinforcements Can Be Replaced with Glass Reinforcements

Luboš Podolka

Abstract: The article focuses on the practical use of composites able to replace helical stainless steel reinforcements, i.e. composites glued into a groove or into a borehole. The paper describes experiments performed with elements reinforced by glass and helical stainless steel reinforcements in the laboratories of the Klokner Institute of the Czech Technical University in Prague (KI CTU). The experiments were subsequently evaluated and compared with a mathematical model created using the ATENA software and technical information provided by the company HELIFIX CZ s.r.o.

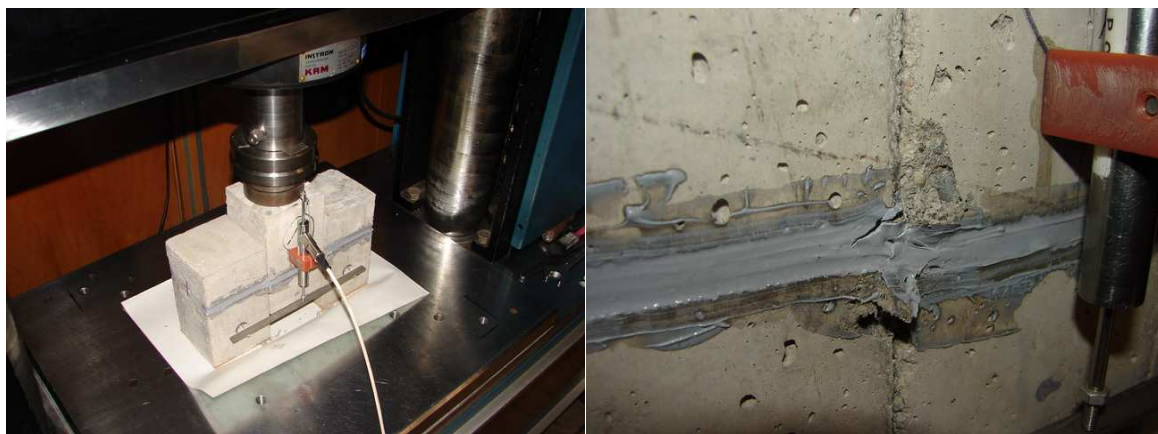
Fig. 1: View of the sample placed in a press and detail of the joint damaged by a shear force.

The elements were three little beams made of C 30/37 XC1 concrete the dimensions of which were 150 x 150 x 200 mm. An 8x10 mm groove was made on one side of the beams and a $\Phi 5$ mm glass reinforcement was put in the groove.
