Damage identification on stringers by modal analysis

Prof. Ing. Milan Sokol, PhD.

Ing. Martin Marton

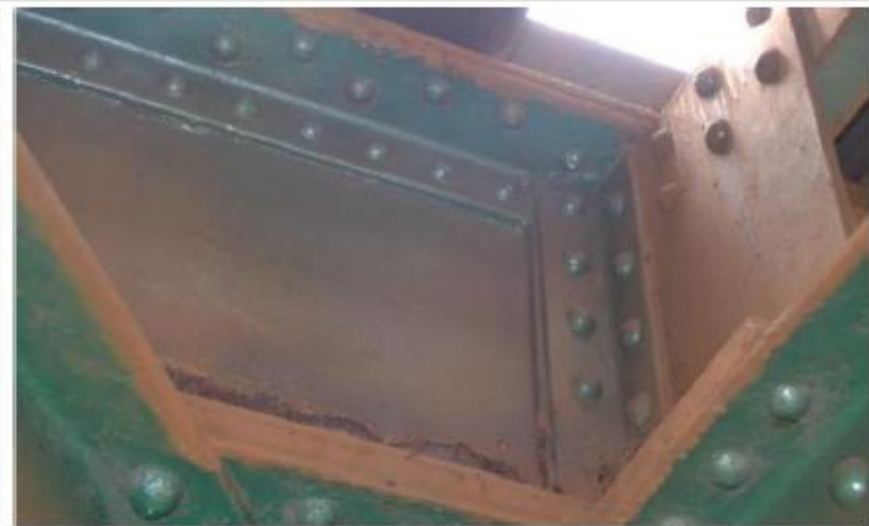
- Many old railway bridges in Slovakia and Czech Republic are at the end of their lifespan
- We know many different types to identify of damage and failures on the structure.
- This article describes a method for detection of changing in stiffness of flange and web stringer connection using higher eigenfrequencies and mode shapes.
- The most common damage is rusting of some parts of stringer

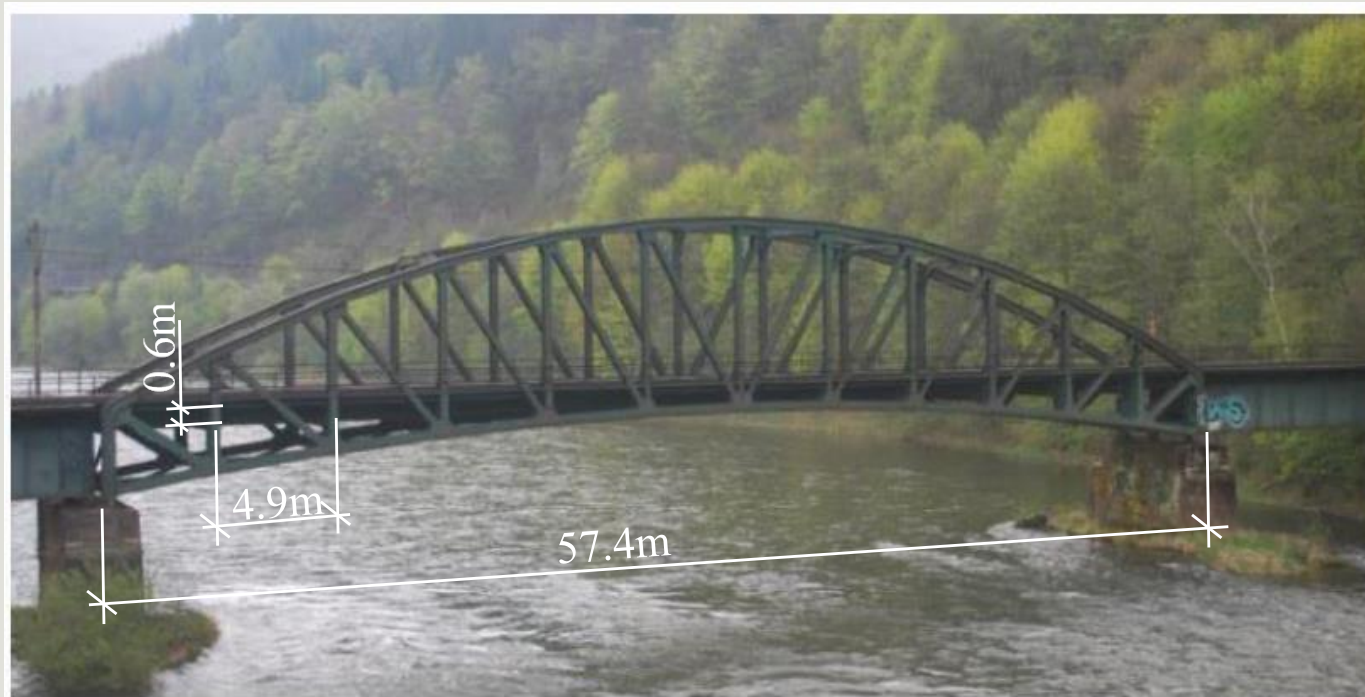
- For this analysis, railroad bridge over the river Váh near Strečno has been investigated.
- The bridge consists of a truss arch bridge with a span of 57.4m
- The length of stringers is 4.9m and its height is 0,6m.
