Svratka, Czech Republic, 12 – 15 May 2014

BLAST PERFORMANCE OF FRC SPECIMENS WITH STEEL FIBERS OF LOW DUCTILITY

M. Foglar^{*}, M. Kovář^{**}

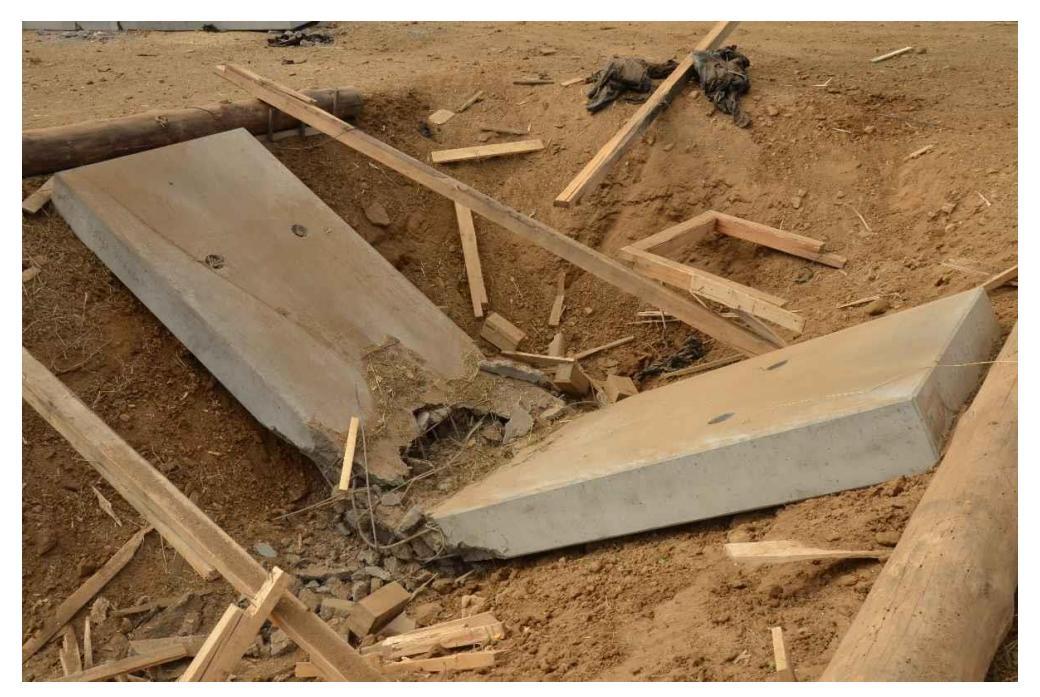
The specimen No. 9 did not sustain the loading and collapsed. The specimen No. 9 after blast can be seen in Fig. 1. The area of the puncture is 1.02 m^2 , volume 0.31 m^3 , which represents 11.3% of the total volume of the specimen. Total volume of the damaged concrete (puncture + spalling) is 0.45 m^3 , which represents 16.7% of the total volume of the specimen. The area of puncture was increased by 131% in comparison to specimen No. 1, total volume of damaged concrete was increased by 95% in comparison to specimen No. 1. The damage to the sides was 100% because area of puncture intervened over the whole width of slab. Cross-section of slab in mid-span was represented by steel reinforcement only.

Fig. 1: The specimen No. 9 after the blast.
